TABLE OF CONTENTS

HISTORY

STRUCTURAL REPORT

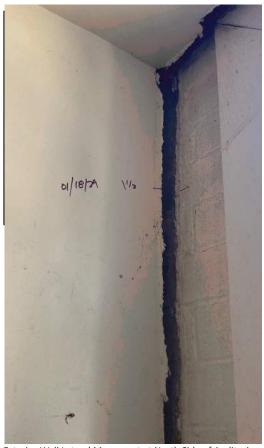
Exterior Wall Lateral Movement at North Side of Auditorium

- The roof truss over the stage has failed completely as mentioned above. This could be due to a number of reasons including the settlement of the foundation in that area, wood destroying organisms, improper original design, or a combination of these. This failed truss is also likely worsening the cracking in the walls since there is no bottom chord of the truss to resist the lateral thrust on the truss due to gravity loads; therefore, the walls are pushing out laterally as observed.
