HISTORIC PRESERVATION REHABILITATION AND DESIGN GUIDELINES

Gainesville, Florida

Supplement to Land Development Code
Section 30-112

**City of Gainesville
Community Development Department**

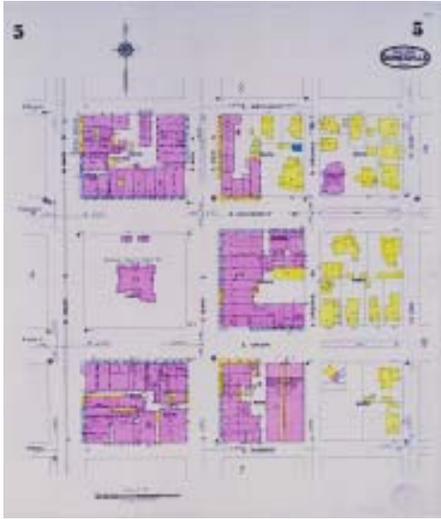
Gainesville Sanborn Insurance Map, Central Business District 1928.

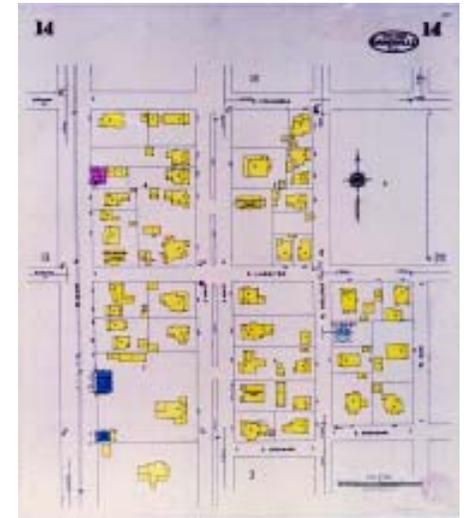
Sanborn Insurance Map of Gainesville's Northeast District, 1928.

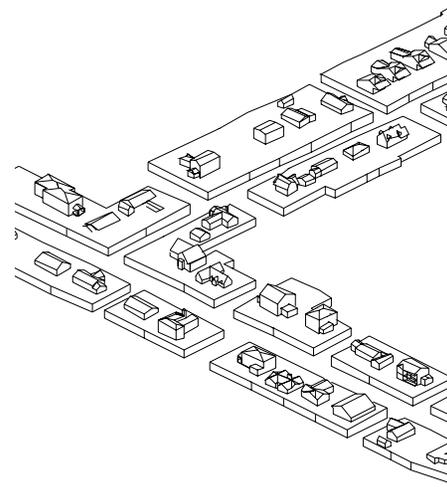
Axonometric study of building form along residential street in Northeast District.

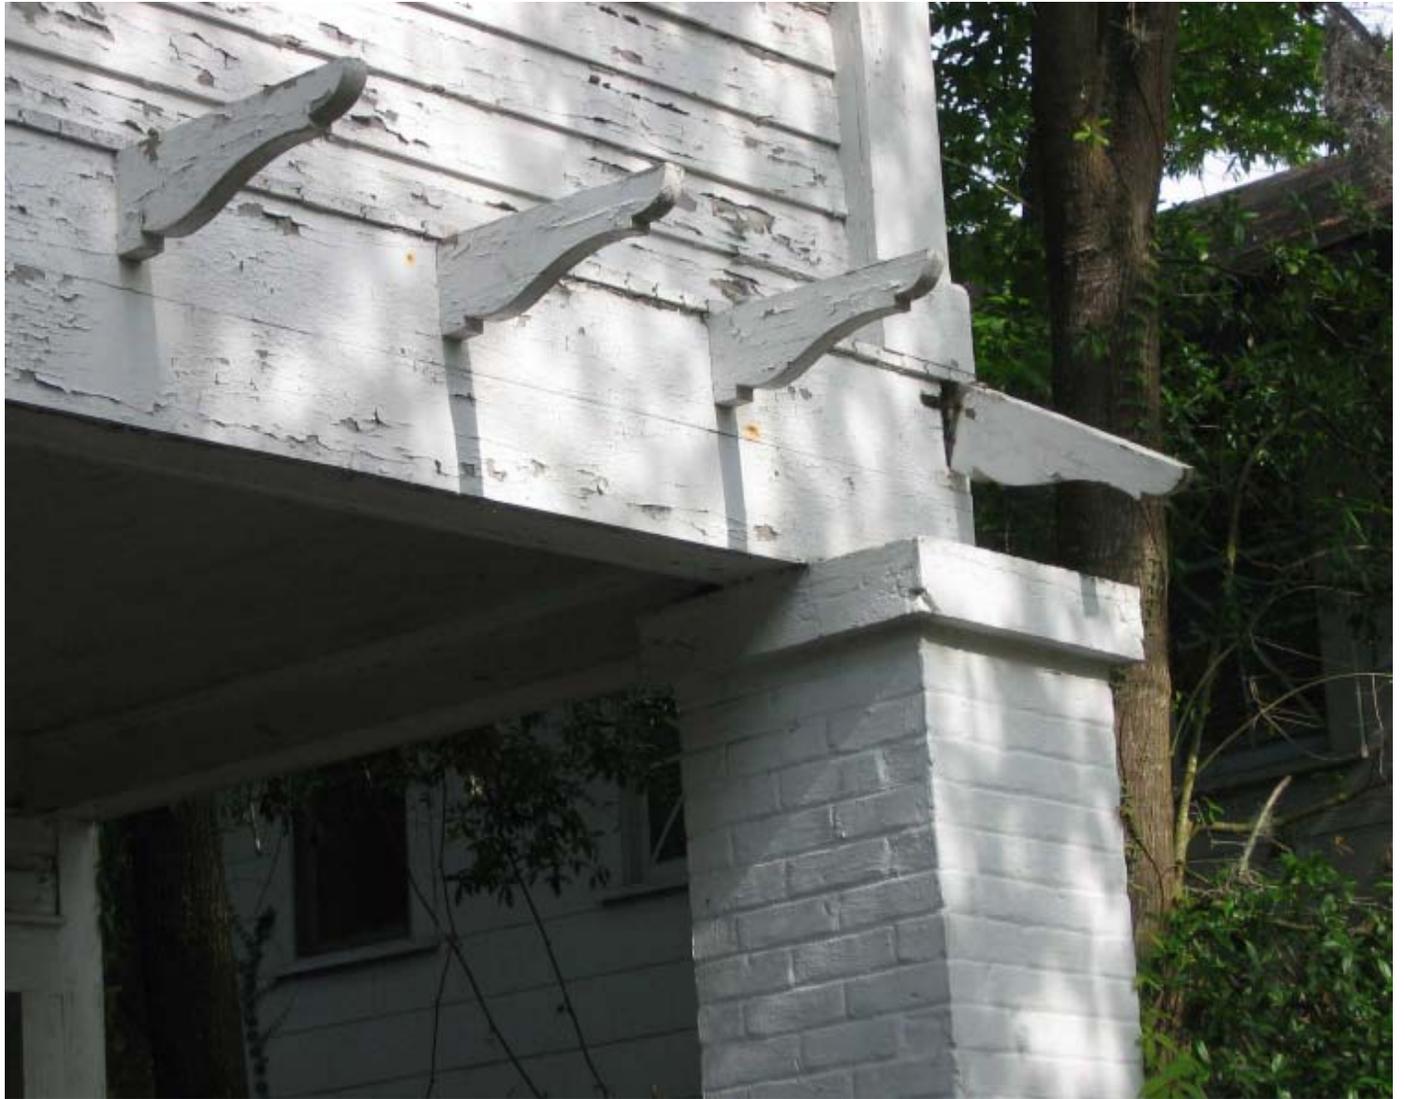
Architectural details in need of repair.

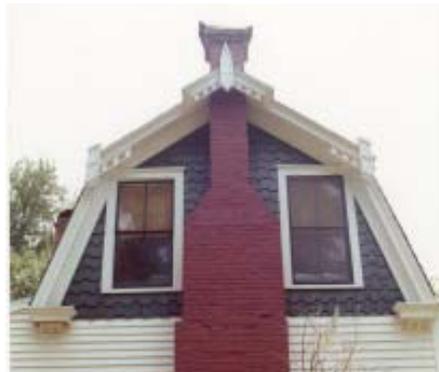
Mansard roof form of Matheson House in Southeast District.

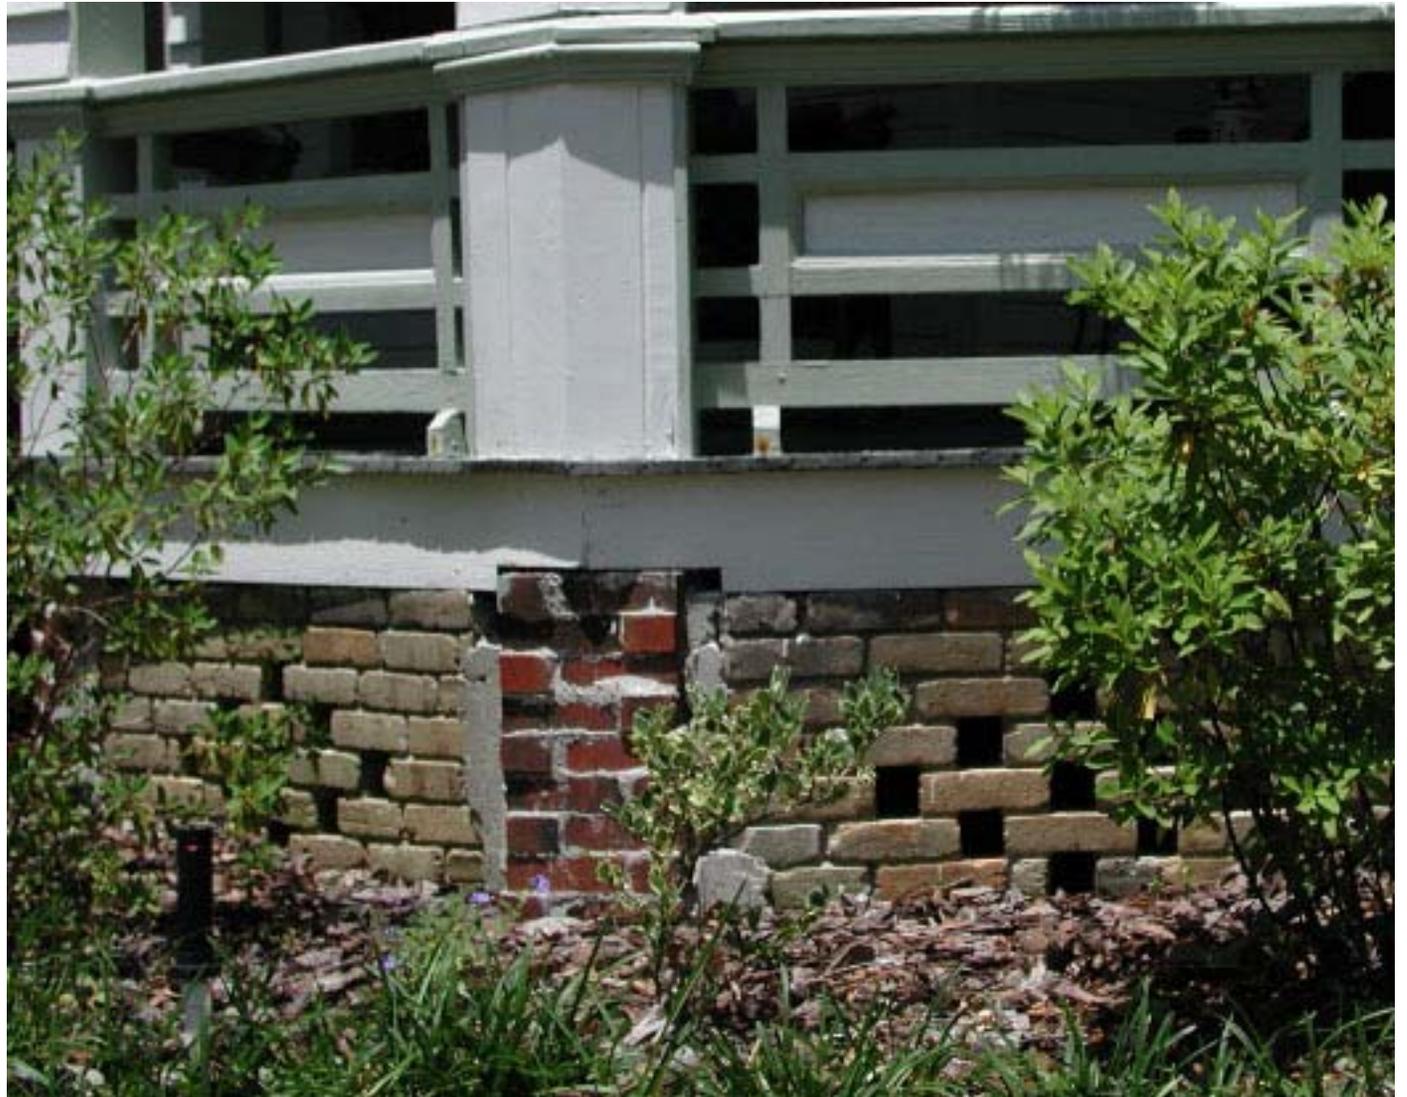
Foundation repairs, the historic materials should be retained, repaired as needed, or replaced with similar materials.

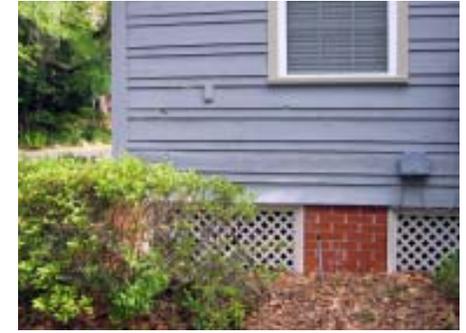
Wood lattice infill with brick pier.

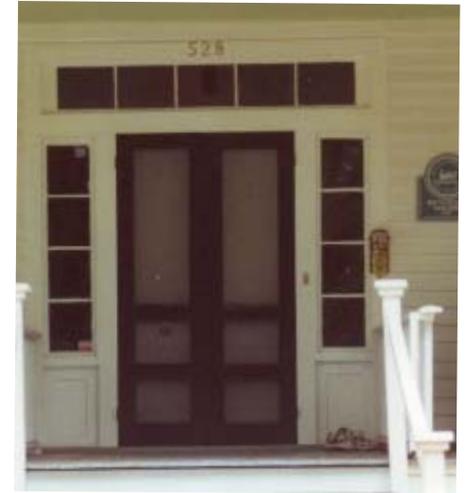
Sidelights that frame the door of the Matheson House in Southeast District.

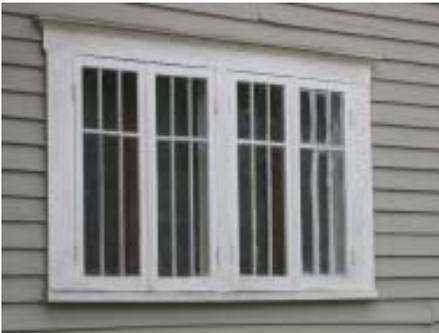
Window with distinctive muntins associated with Craftsman/Bungalow style in University Heights North District.

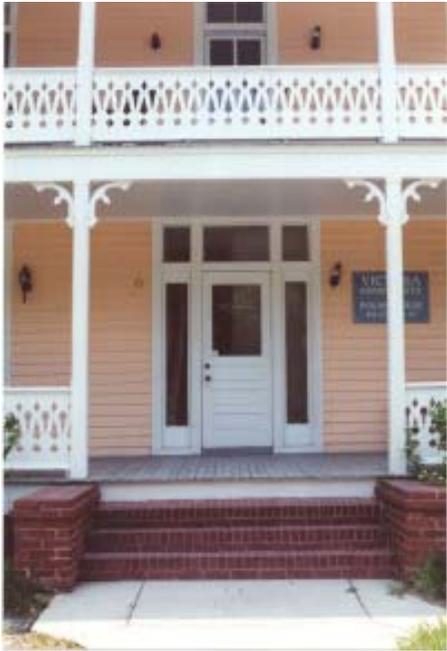
Side lights and transom on door of Pound House in Southeast District.

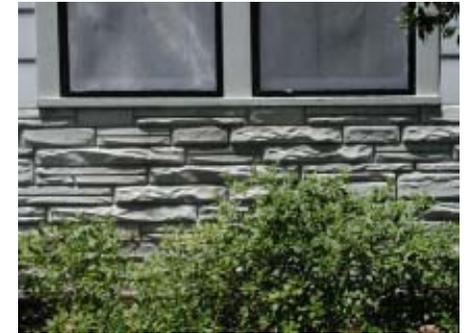
Fieldstone at base of residence.

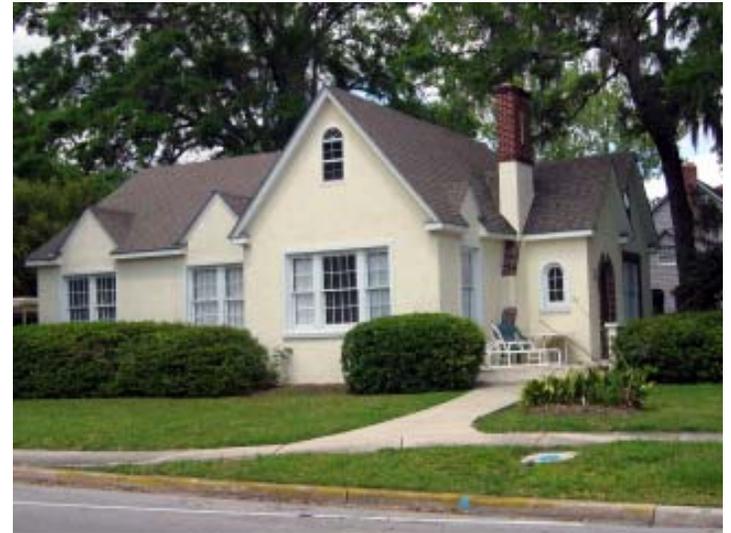
Textured stucco finish.

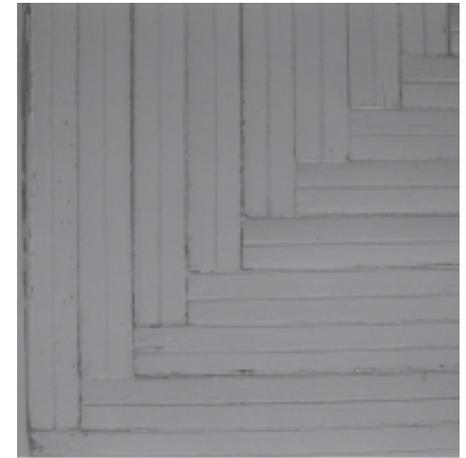
Detail of ceiling on porch of the Medlin House, Southeast District.

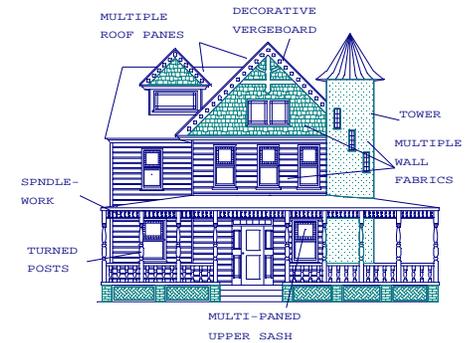
Elevation drawing of the Queen Anne style building.

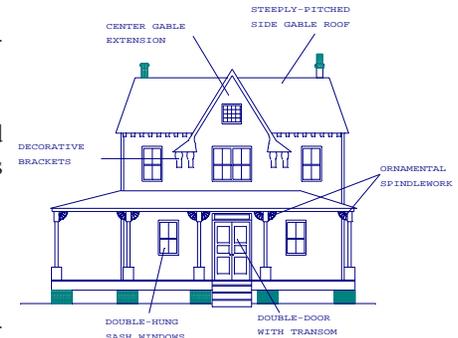
Elevation drawing of the Gothic Revival style building.

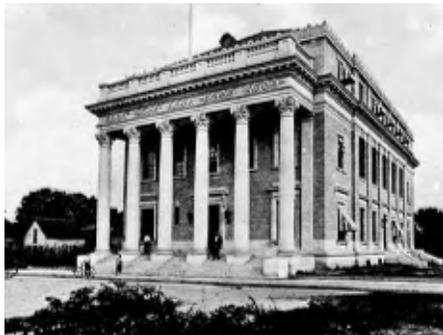
Elevation of the Beaux Arts style building.

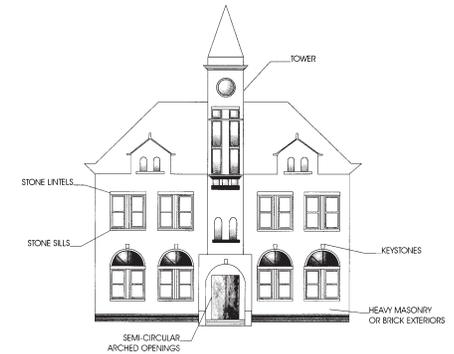
Elevation drawing of the Romanesque Revival style building.

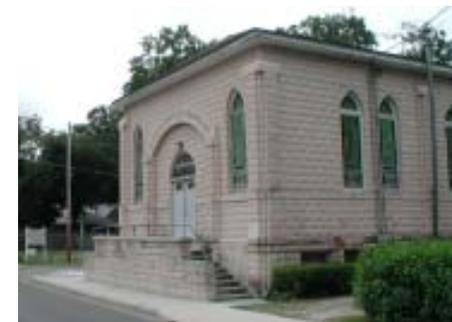
Rusticated concrete block utilized on the Friendship Baptist Church, Pleasant Street District.

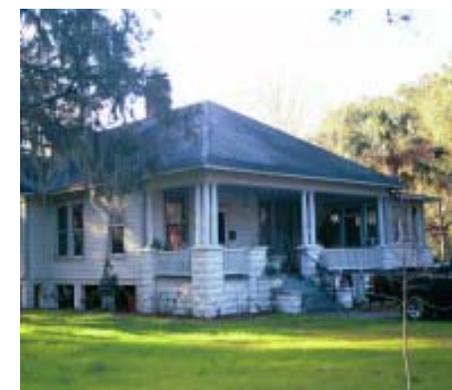
Rusticated concrete block utilized on the foundation of a residence in Northeast District.

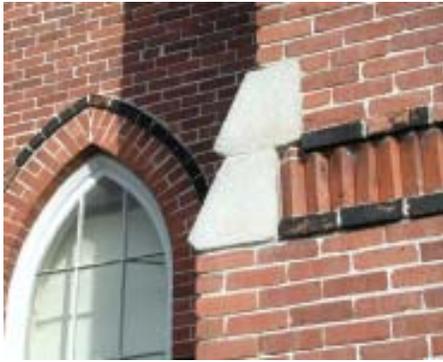
Detail showing stone used in combination with brick in Northeast District.

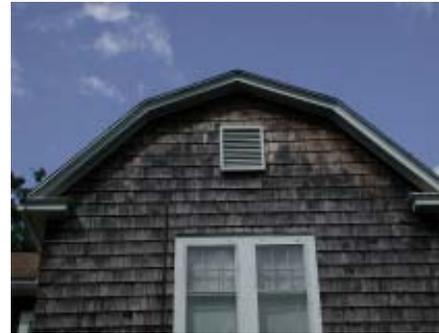
Wood shingles on residence in Northeast District.

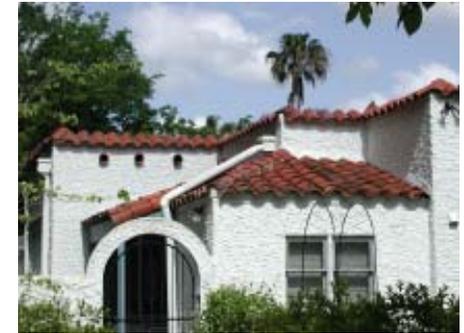
Terra cotta roofing tile and ornament exhibited on Mediterranean style residences in Northeast District.
