Thelma A. Boltin Center Project Update

Betsy Waite, PE

Director of Wild Spaces & Public Places

September 4, 2025

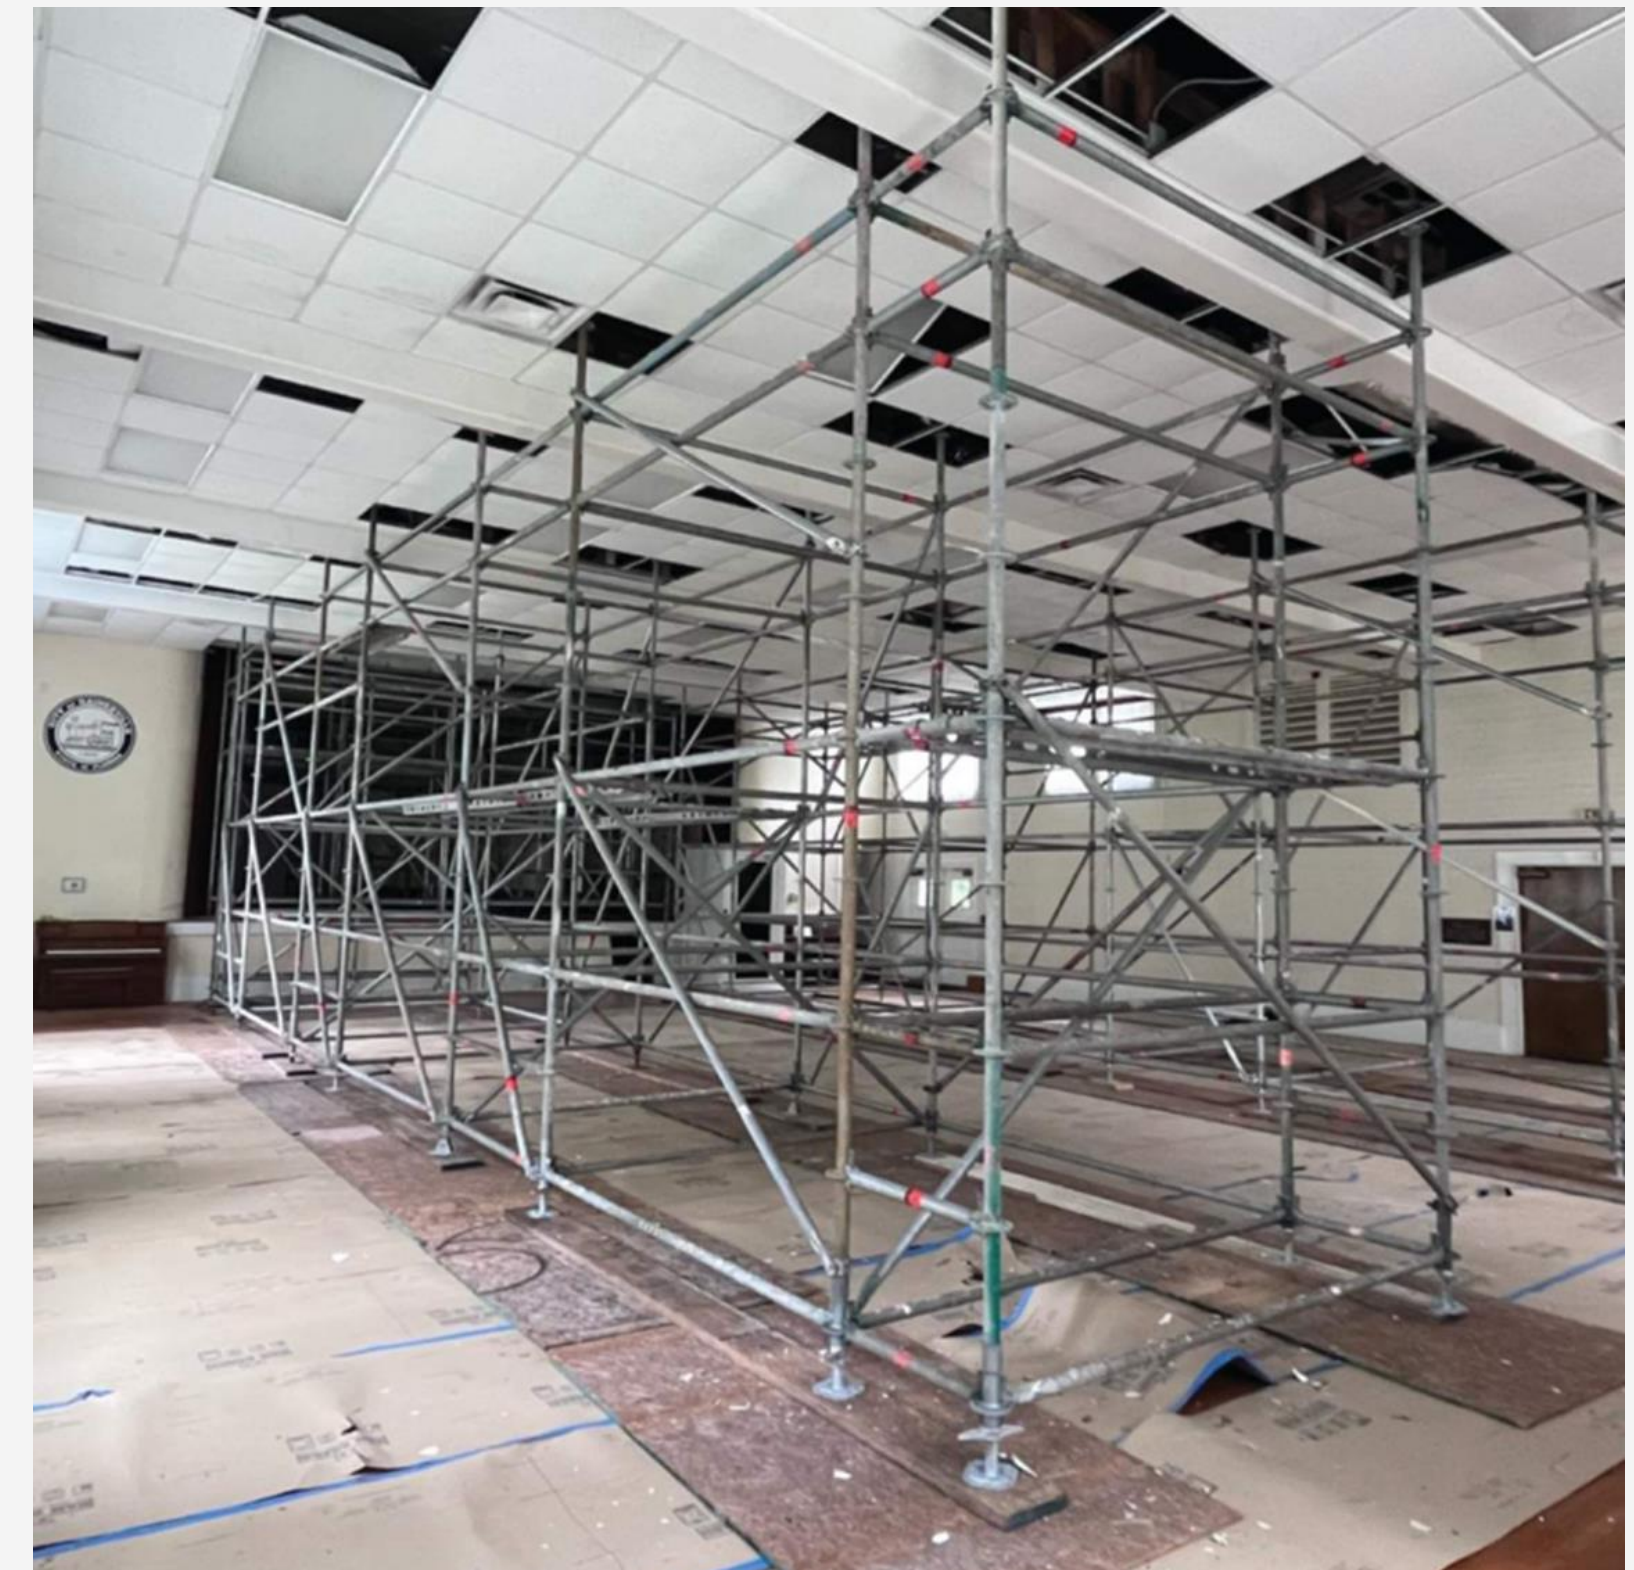
In December 2020, City staff identified a **structural failure** in the building's roof. As a result of the structural concerns and the need for temporary shoring, the building **remained closed** to the public.

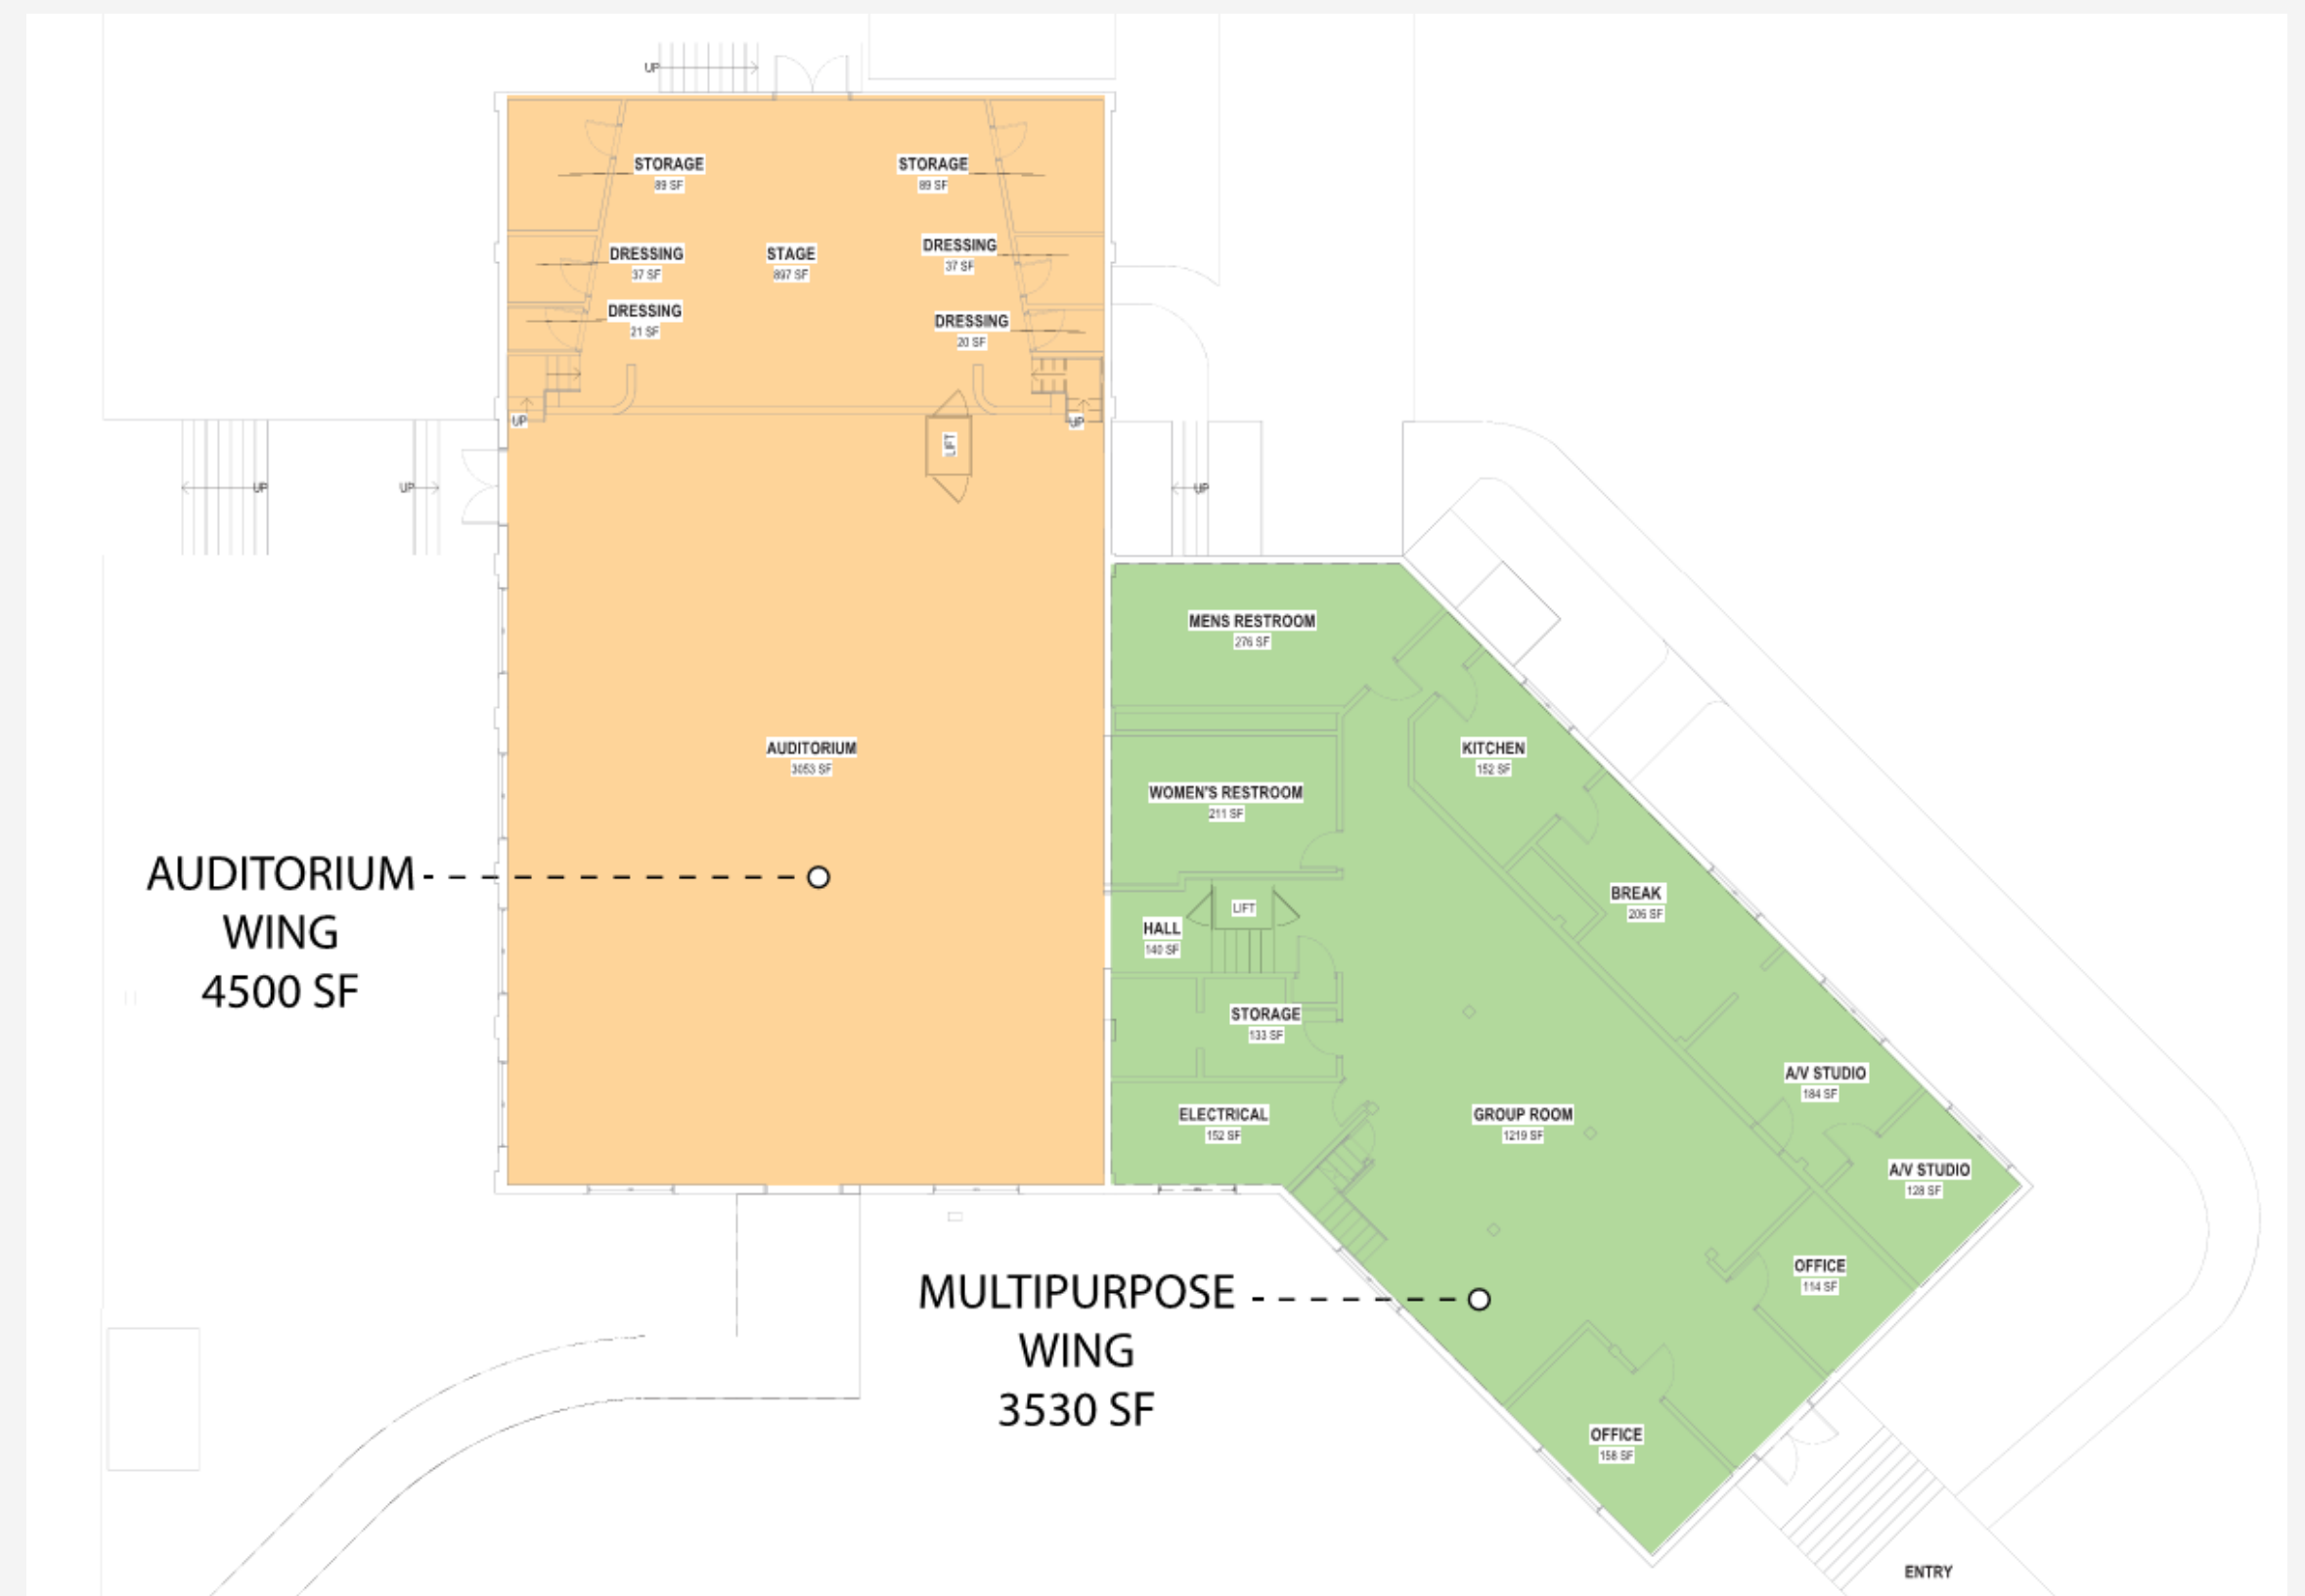
The Thelma A. Boltin Center consists of a one-story **4,500 SF auditorium** (including stage and back of house), and a two-story **3,530 SF multipurpose wing** with 1,120 SF storage mezzanine.

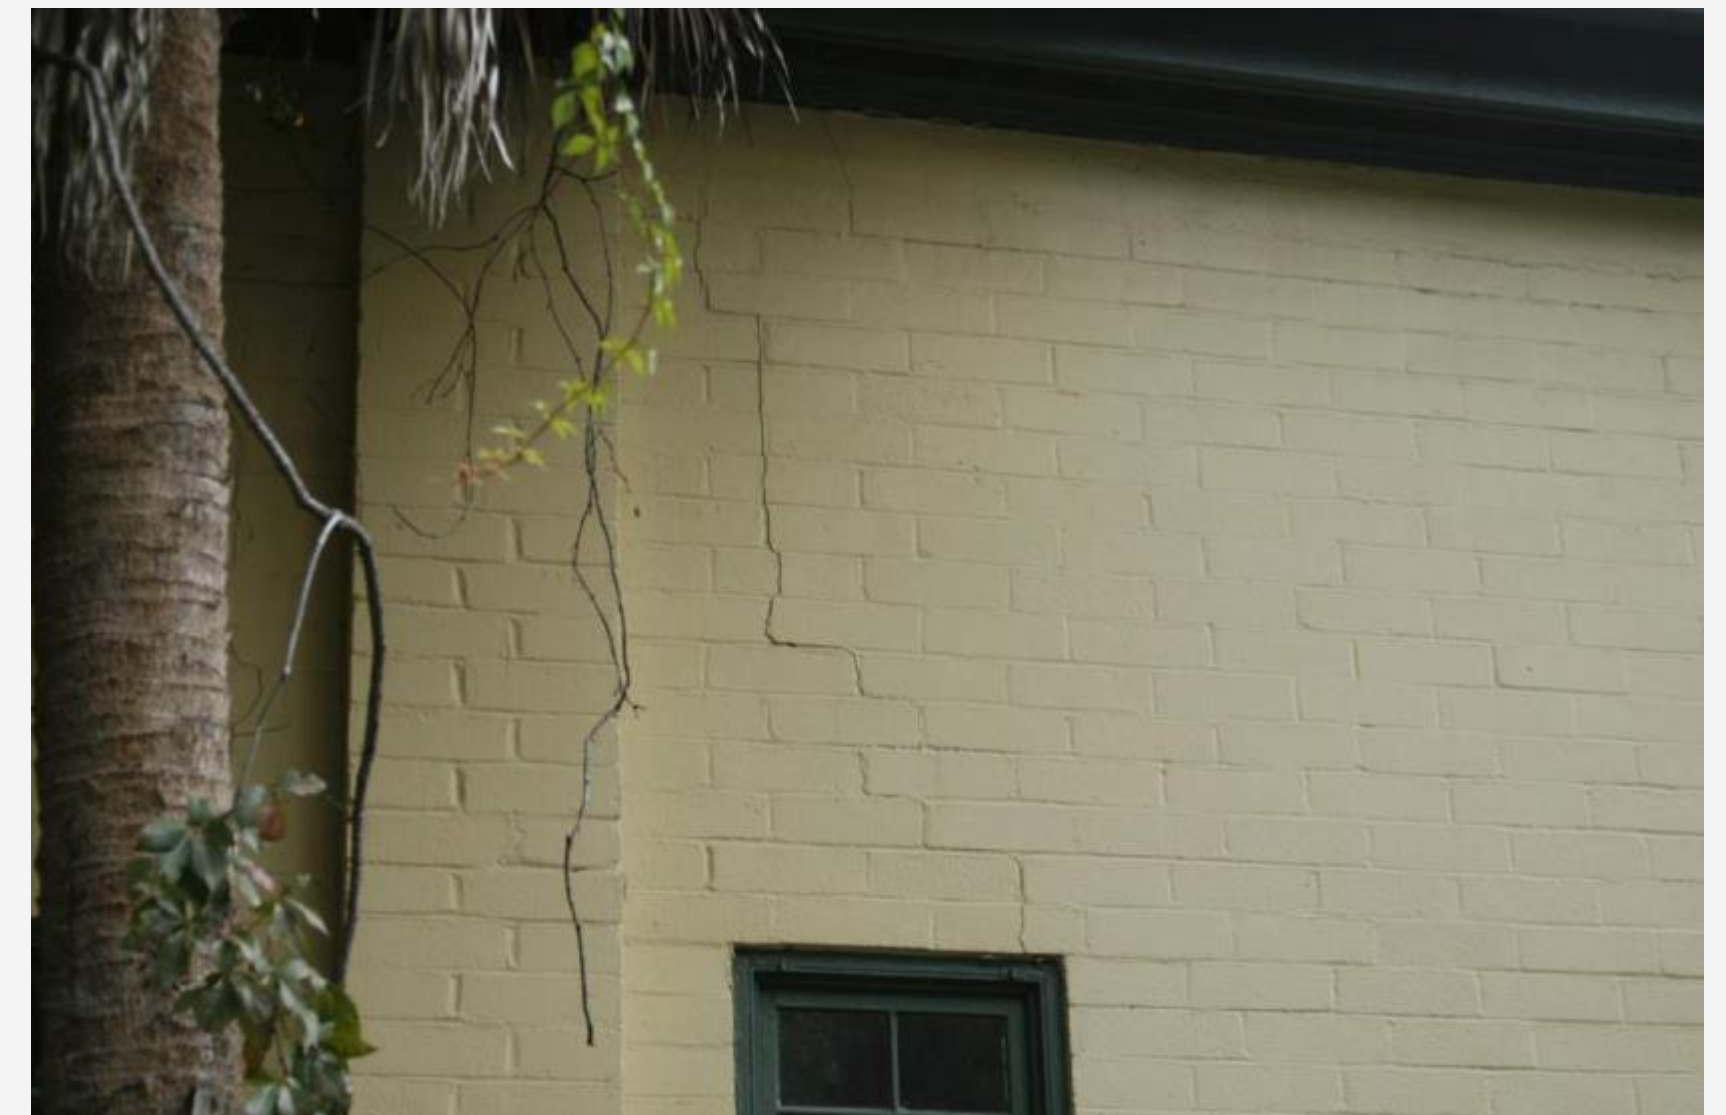
The exterior walls are 4" and 8" painted and unreinforced CMU blocks supported on shallow strip and spread foundations.

The gable roof structure consists of heavy timber roof trusses spaced at approximately 12 feet on center, spanning 49 feet, and supporting wood purlins and wood decking. The roof trusses bear on larger CMU pilasters built integral with the exterior walls.

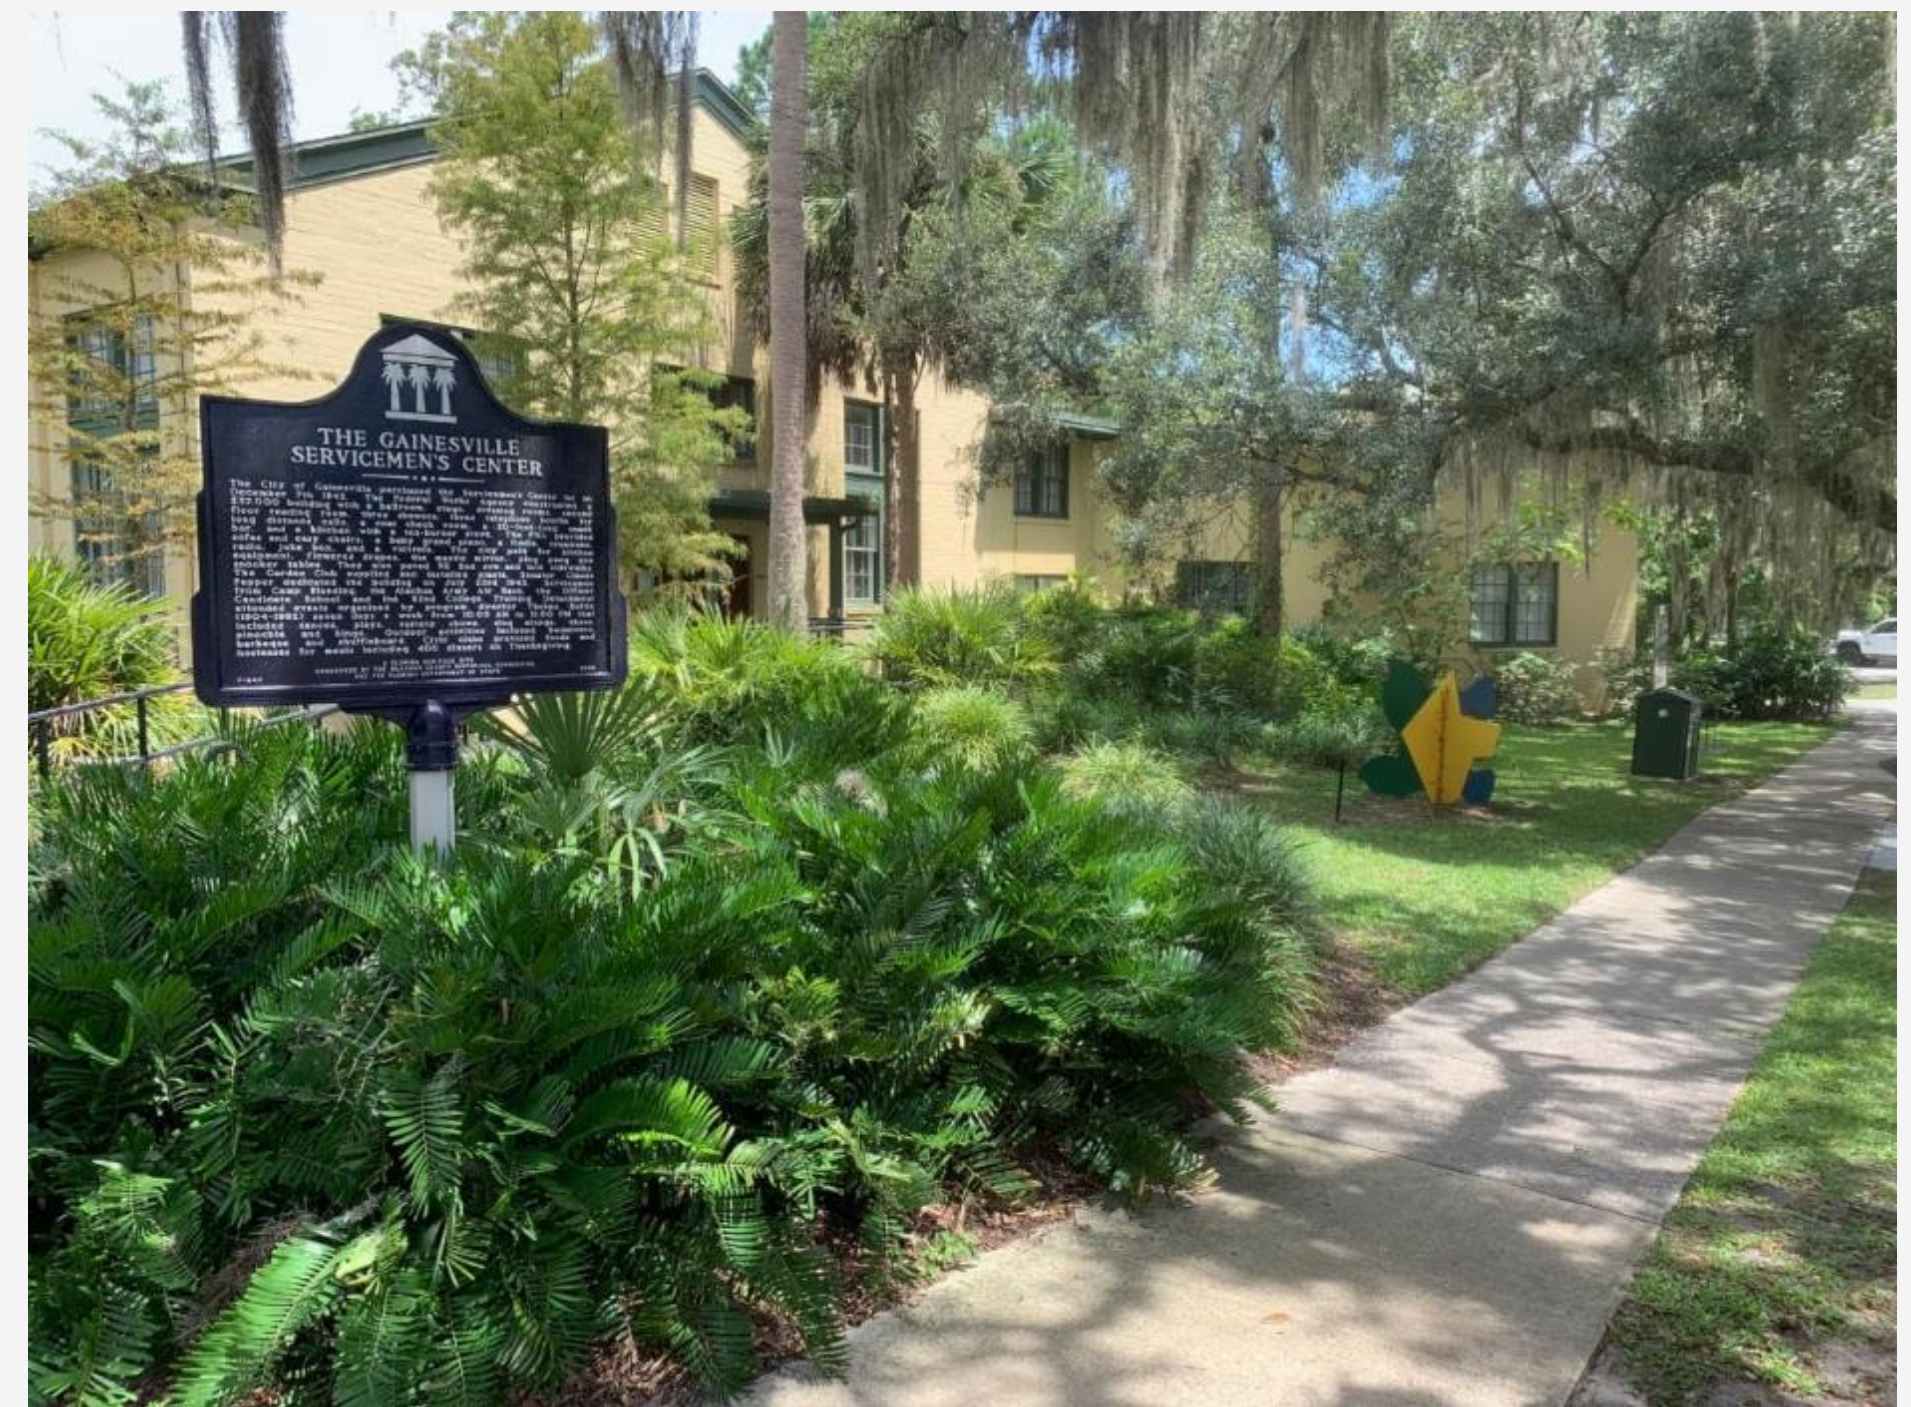
- **Foundation Settlement** – The relative floor elevation in the multipurpose wing varies by about 4 inches, with a downward slope from the northwest to the southeast.

- **Foundation Settlement** – Underpinning the multipurpose wing by installing helical piles.
- **Roof Failure** – Installing a new roof deck, steel roof trusses, insulation and asphalt shingles.
- **Masonry** – Repair and reinforce the historic windows (install steel lintels) and install new cast-in-place concrete footers in the auditorium.

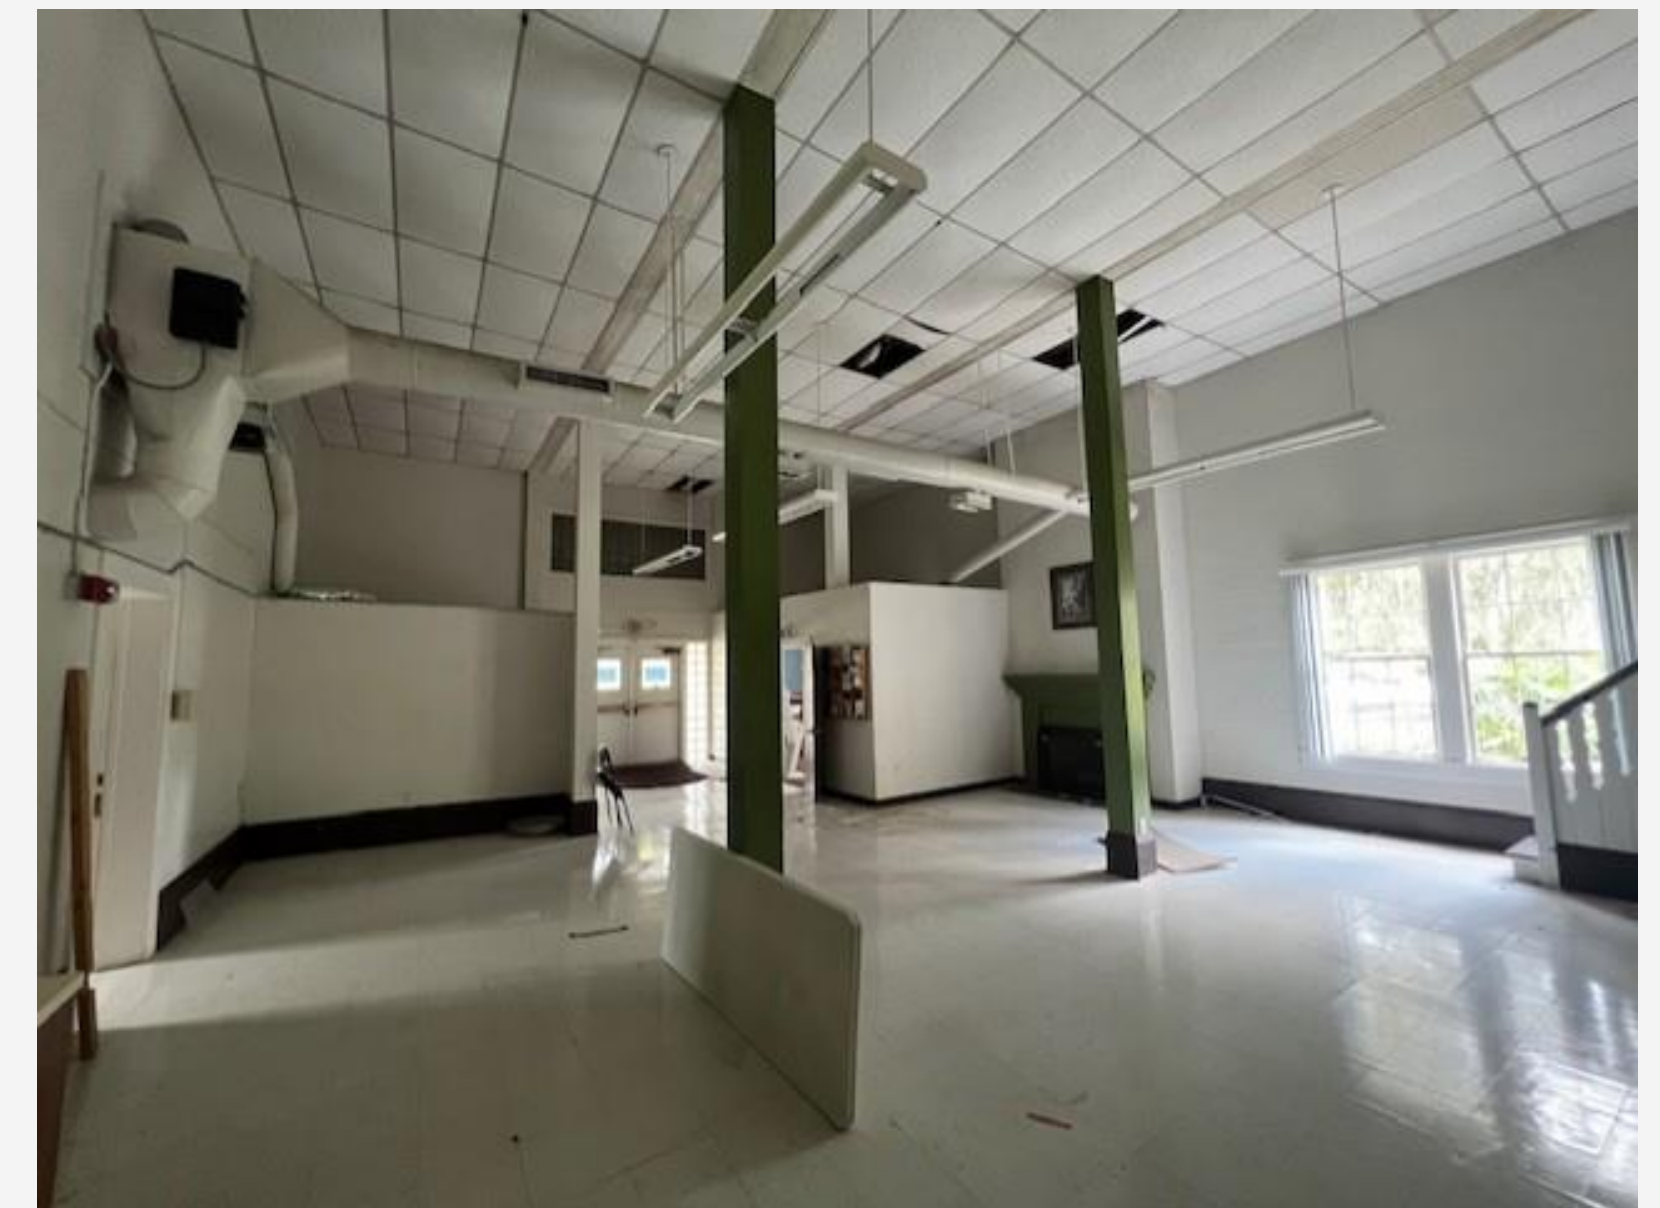
All units are at or are **beyond their useful life**. The units do not provide mechanical ventilation for the stage area, which is recommended based on occupancy and for positive pressurization. The restrooms are not heated or cooled. Refrigerant was removed from the system in accordance with Code requirements after the building was deemed hazardous. **Full replacement of all HVAC systems is required.**

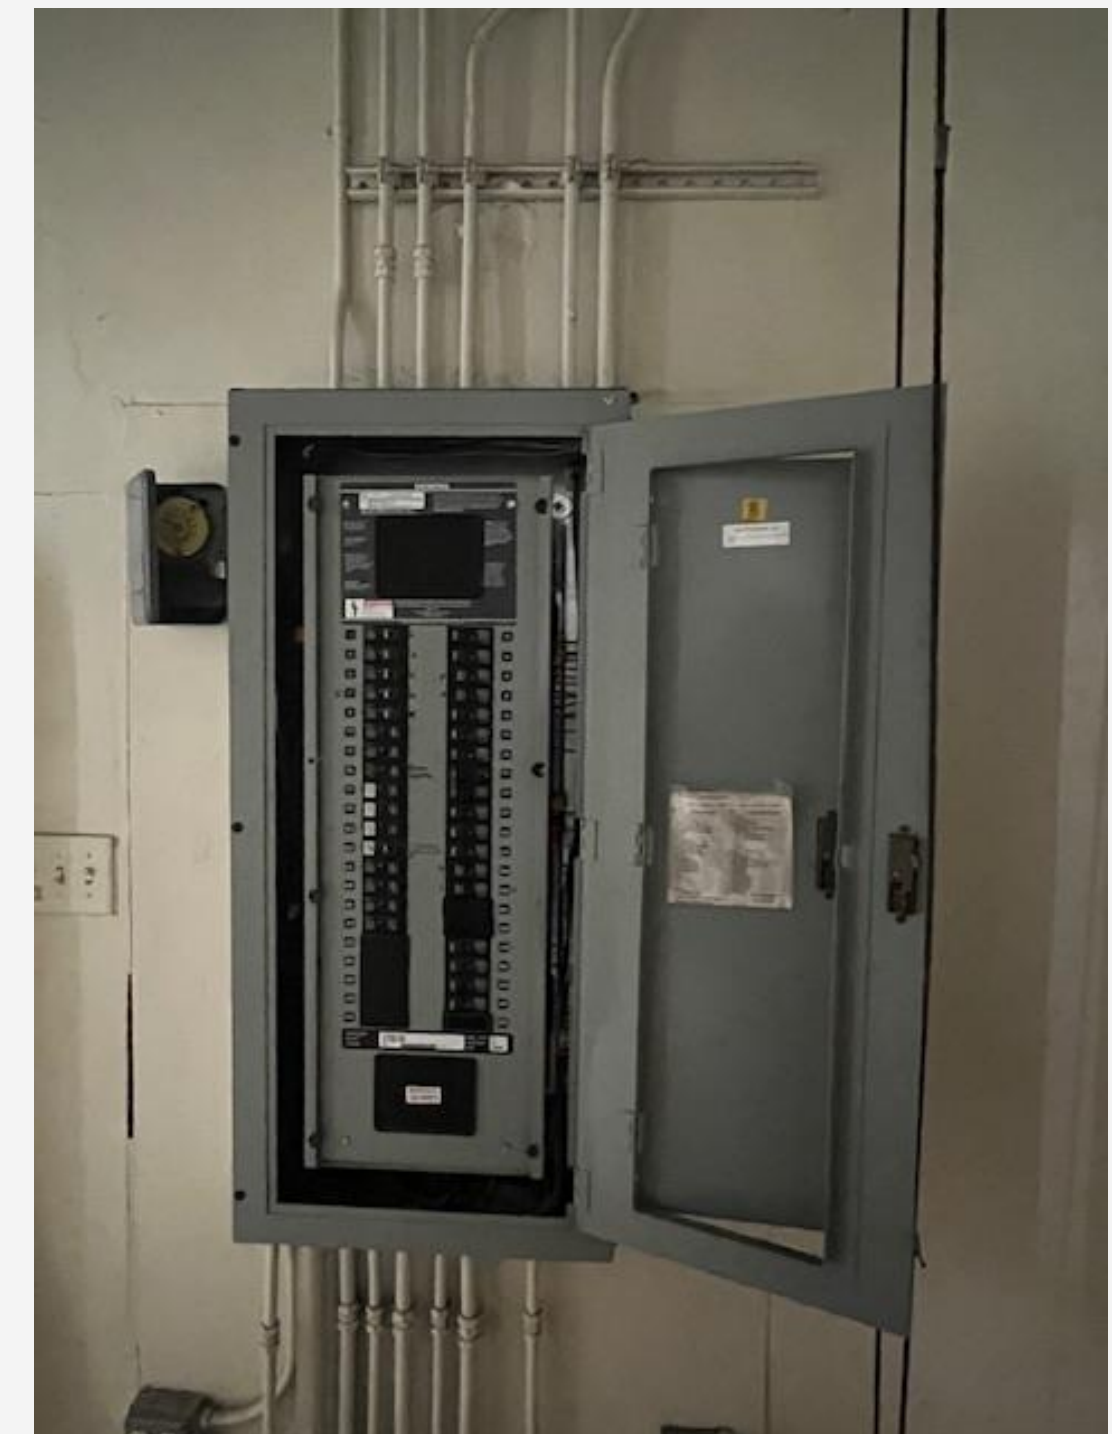
A new panelboard is needed for additional branch circuits.

However, existing electrical panels and wiring devices are also in good condition.

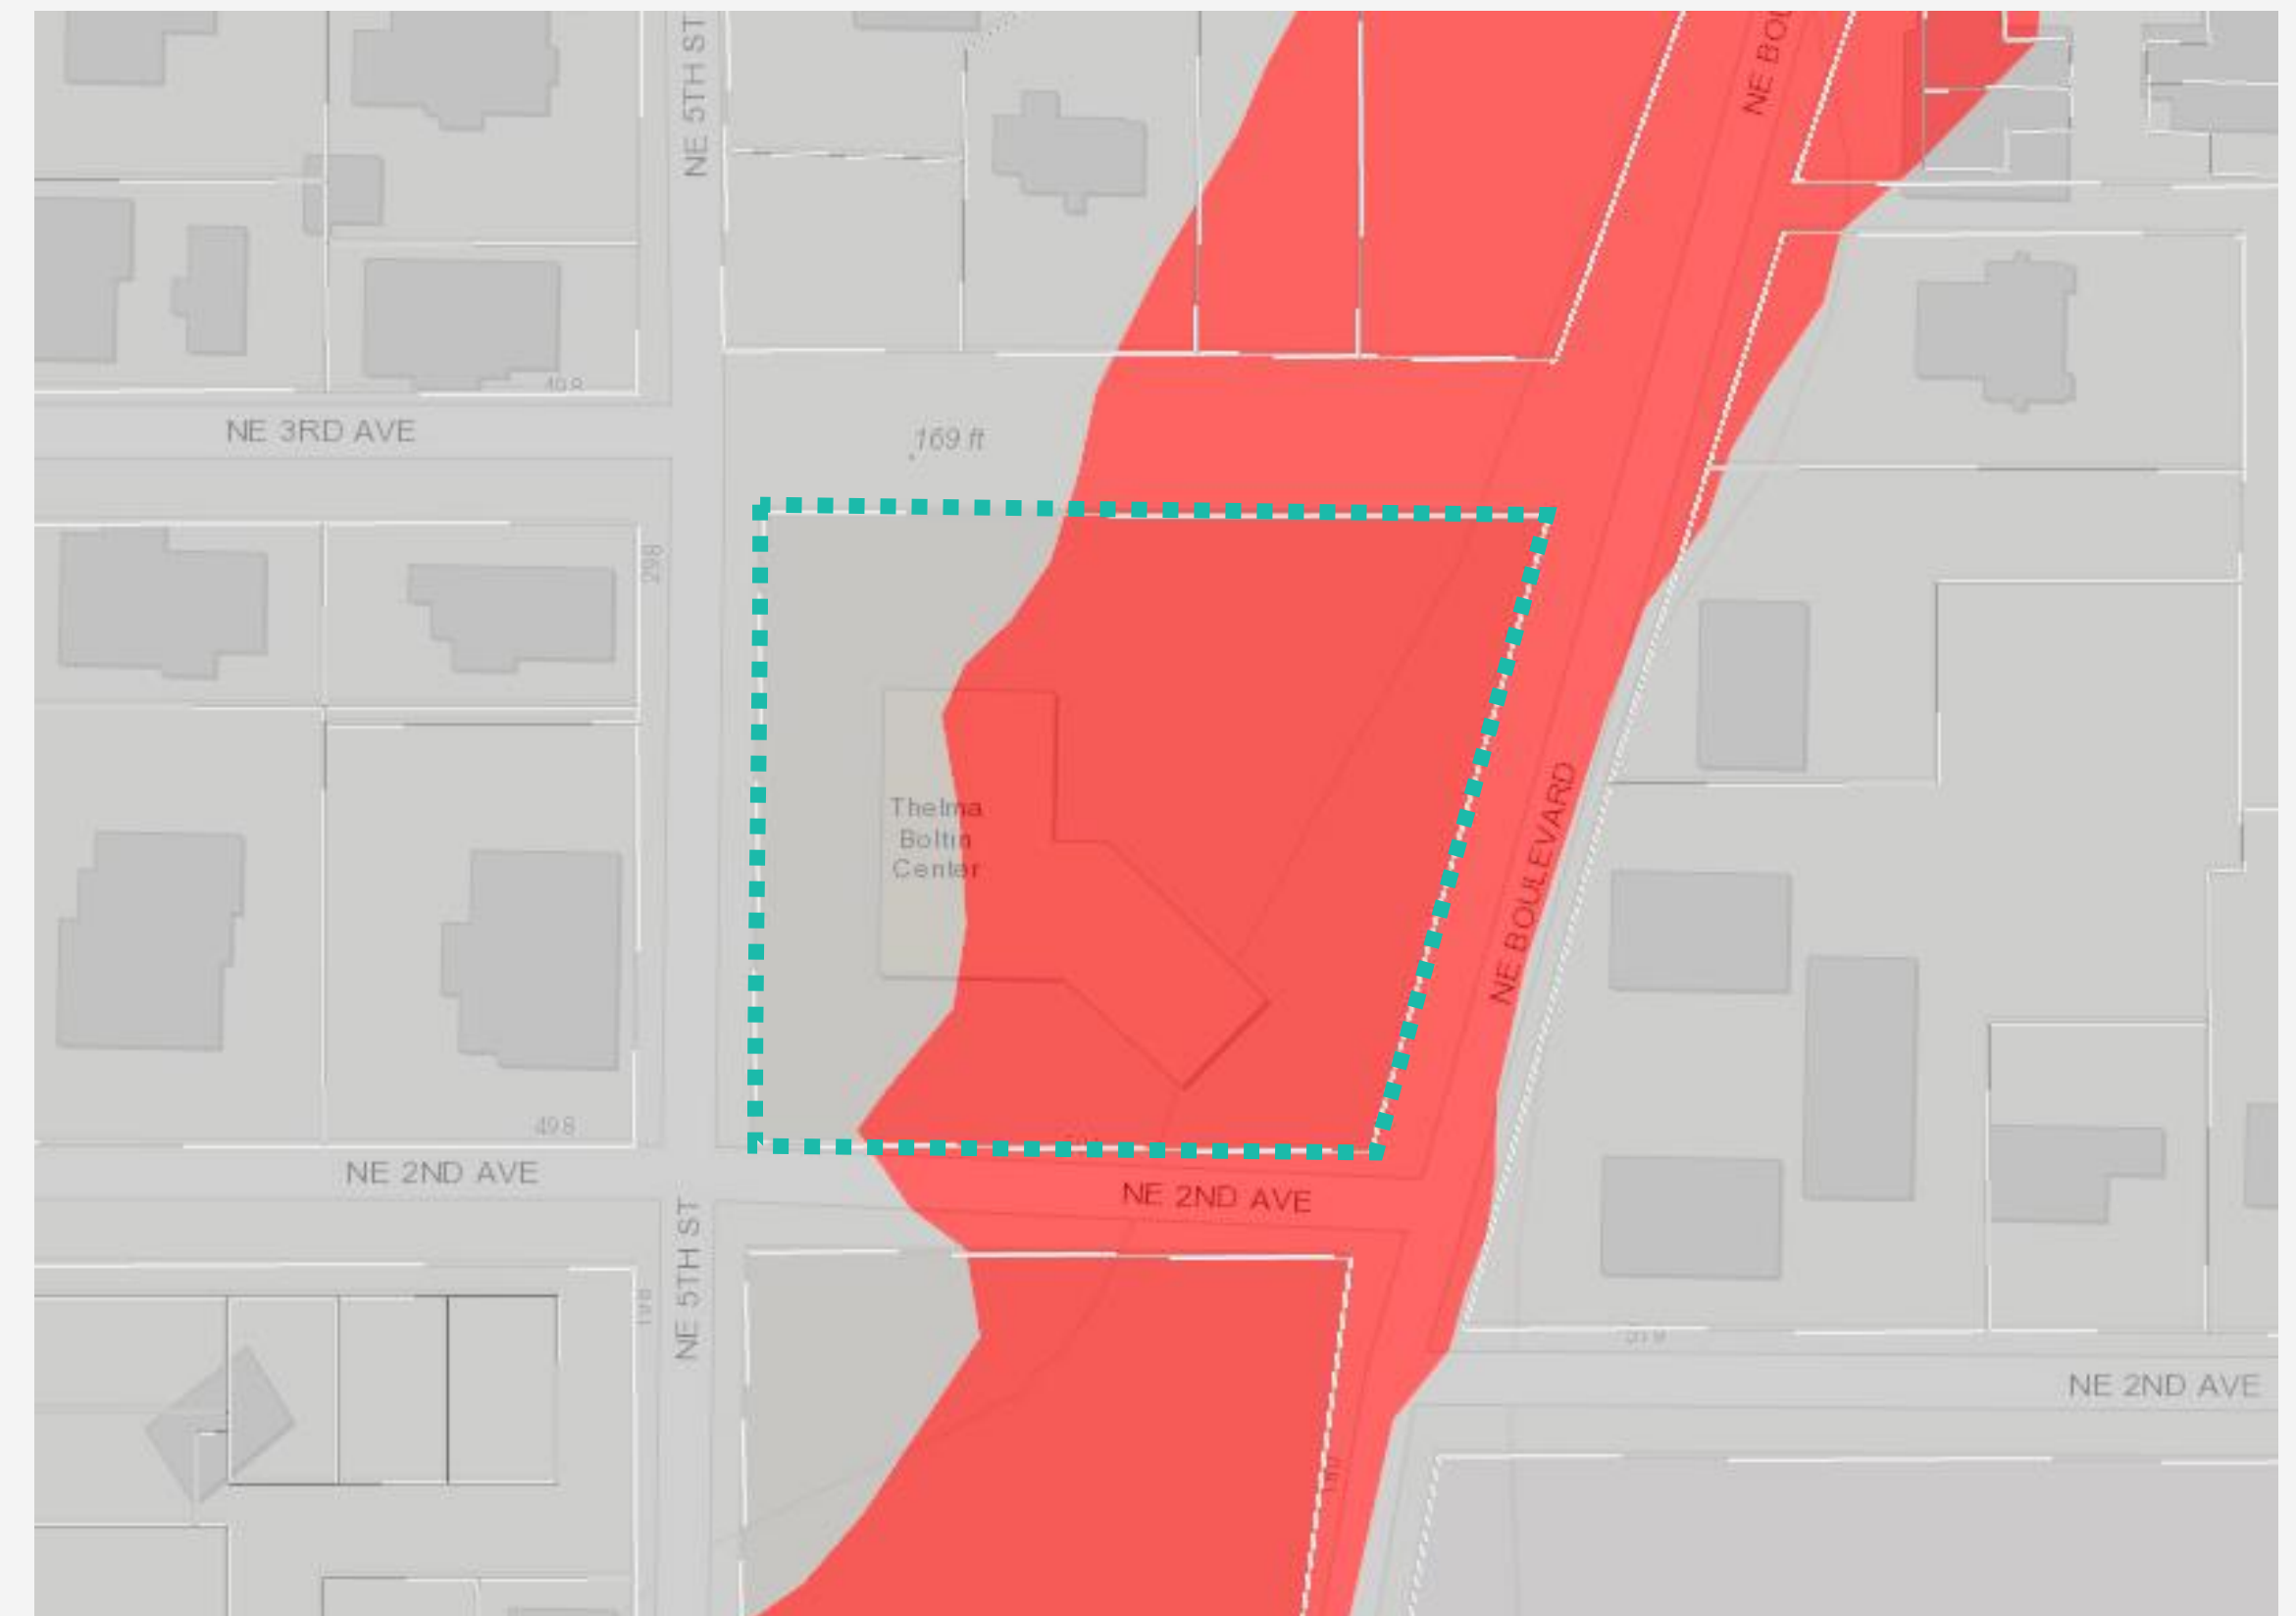
A portion of the site is located within the
100-year FEMA Flood Plain (Zone A).

Sweetwater Branch Creek runs through the
eastern portion of the property.

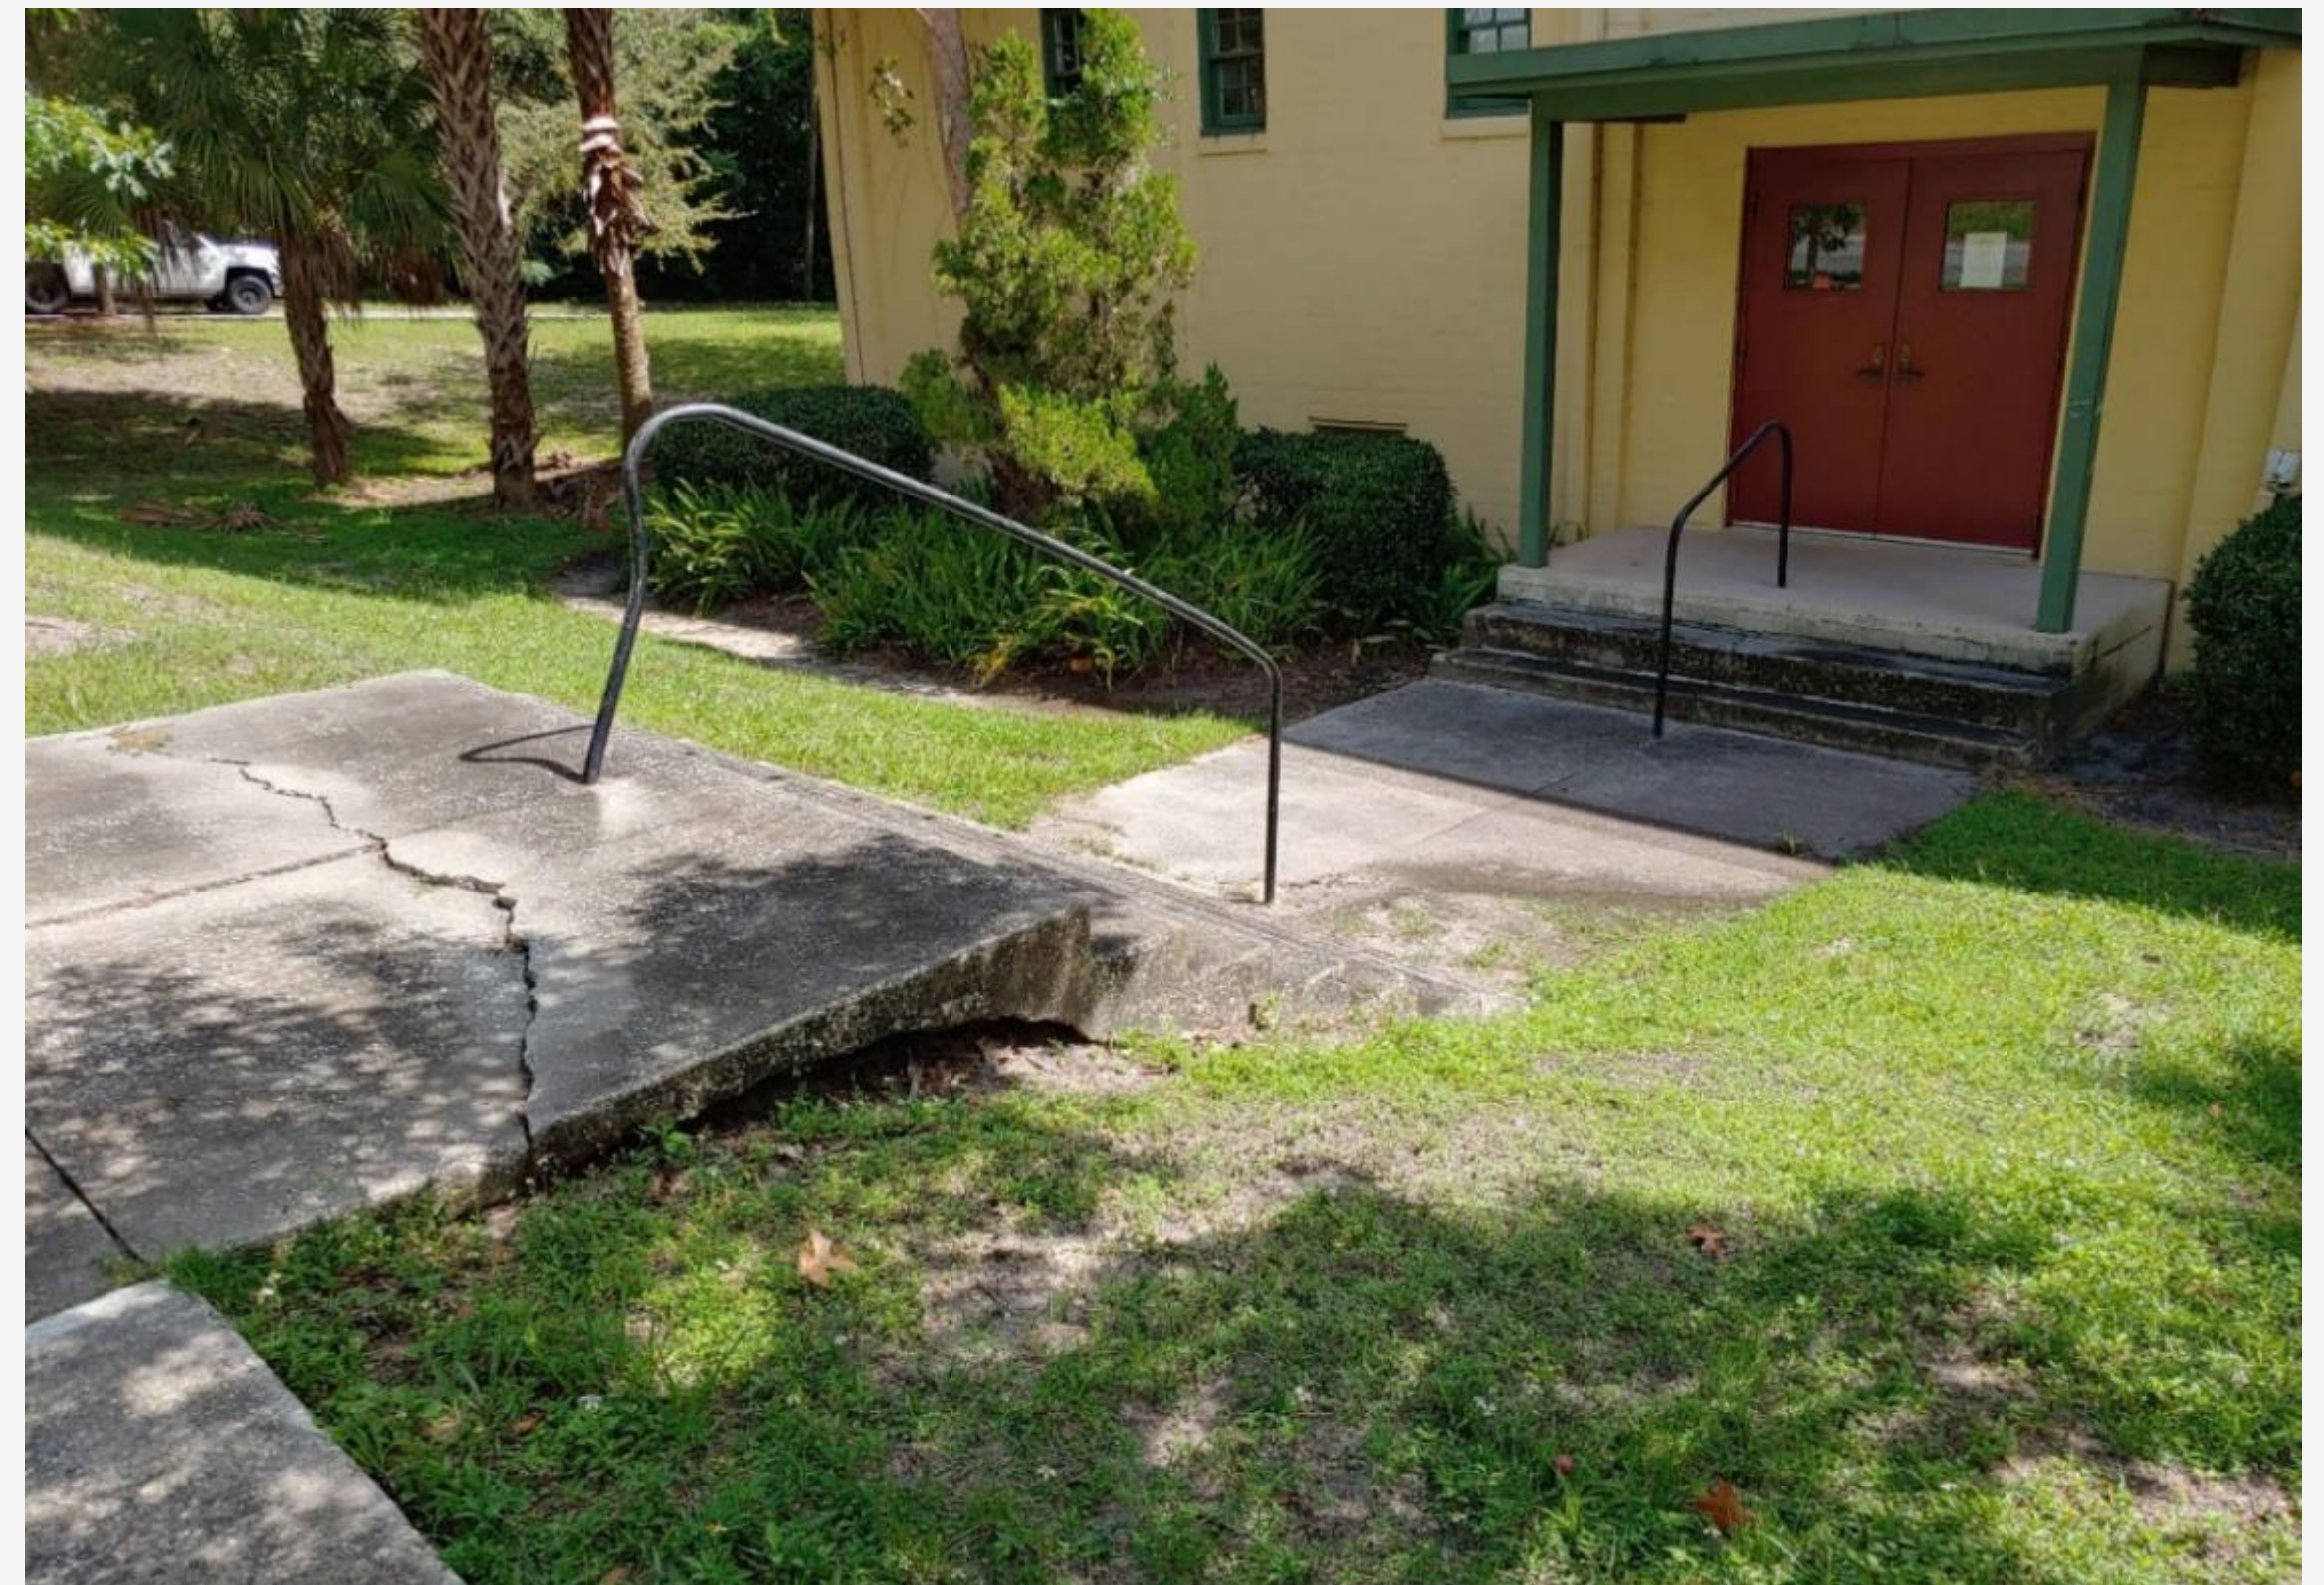
Soil samples from the site indicate the tested soil consists of **poorly graded sand with silt**, some which contain wood and organic material, silty sand with organics, clayey sand, and peat.

The **groundwater table** at the time of the geotechnical investigation was measured at depths of **1 foot 8 inches to 4 feet BLS**.
