Thelma A. Boltin Center Project Update

Betsy Waite, PE

Director of Wild Spaces & Public Places

September 4, 2025

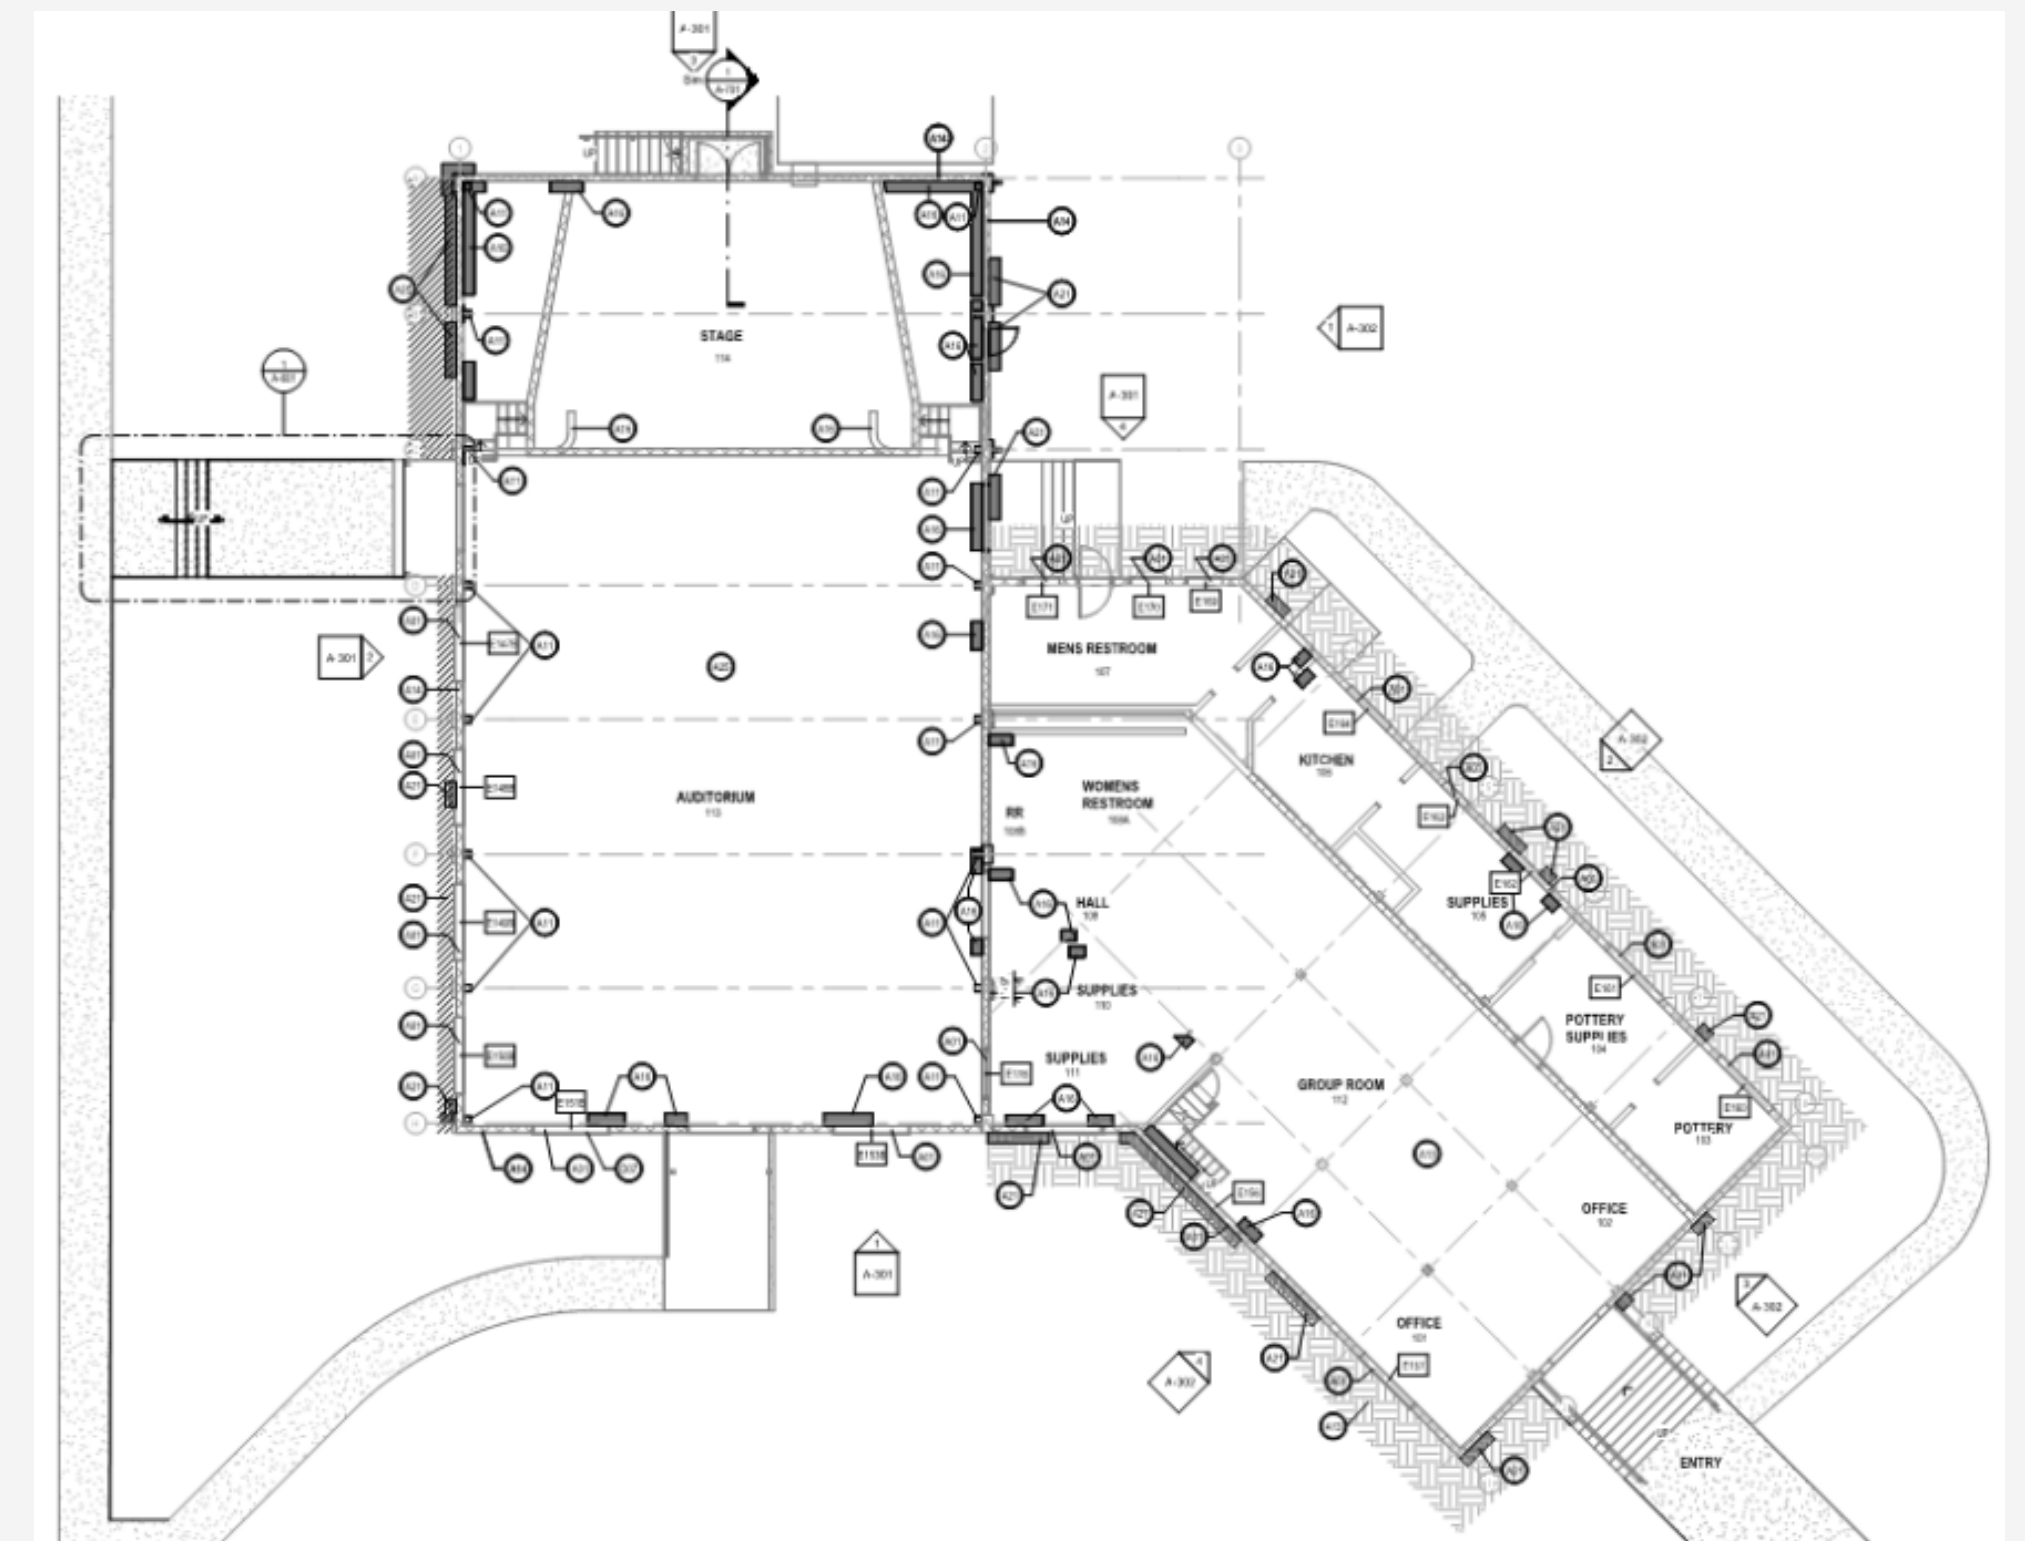
This option maintains full historical integrity of the **exterior** of the existing building. The interior will be gutted and renovated to accommodate new HVAC and electrical.

The Interior would be reconfigured for improved access to the bathrooms and placement of ADA lifts.

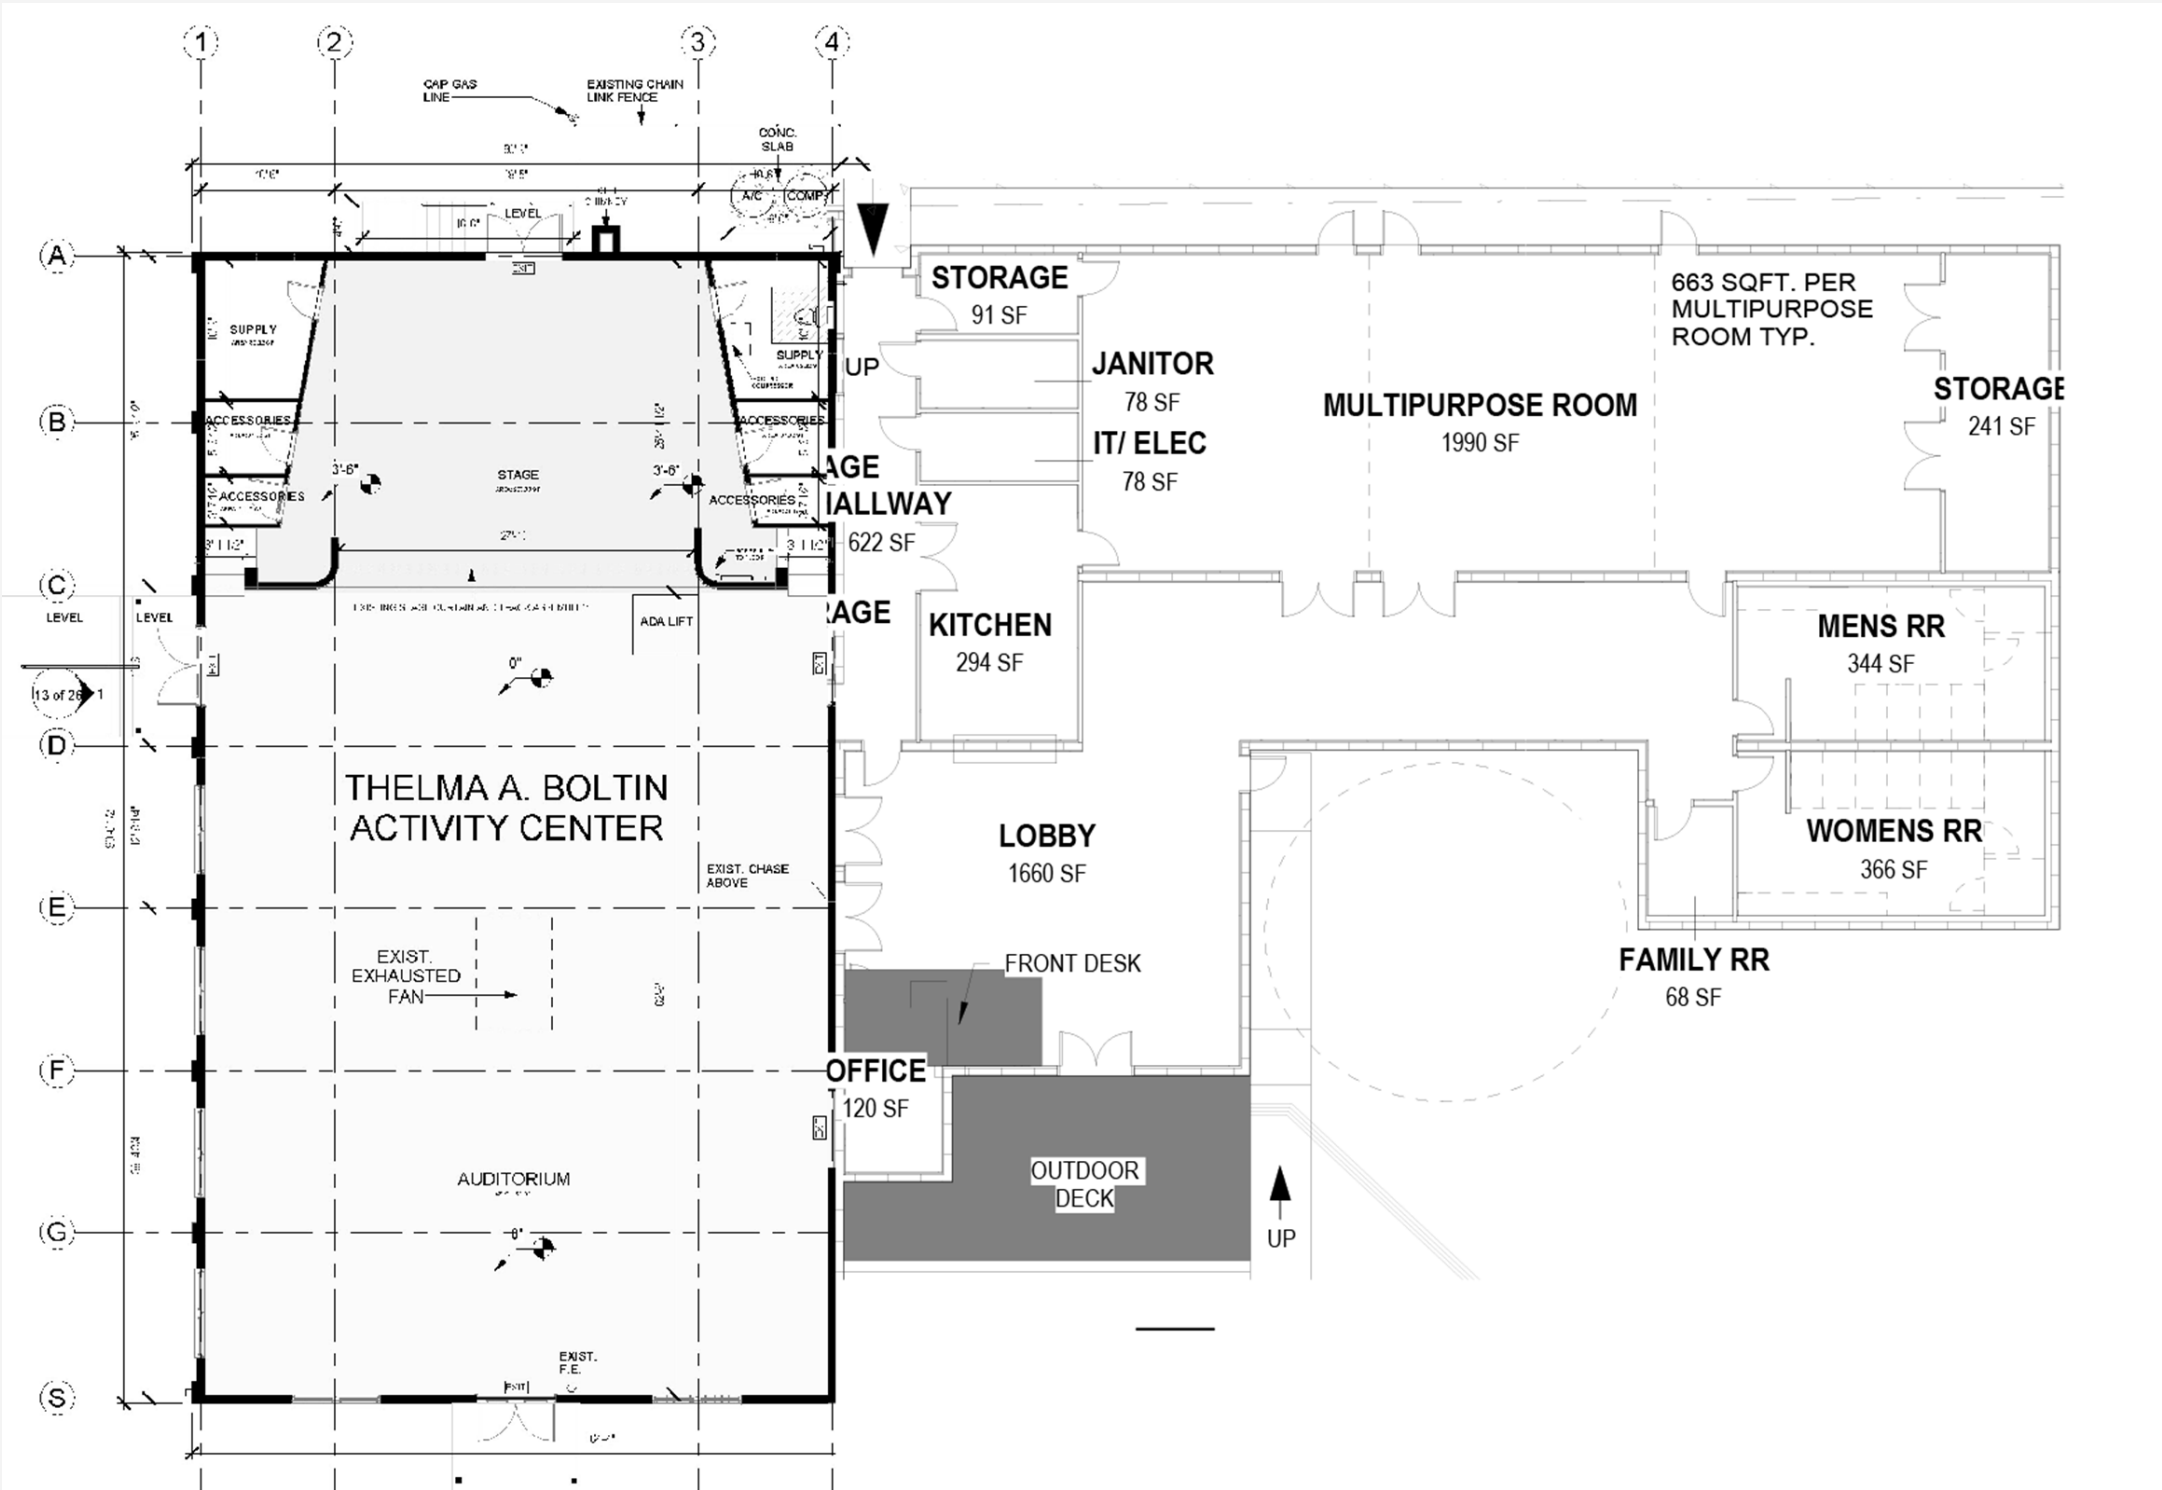
Per conditions of the Certificate of Appropriateness approved December 2022, this option **demolishes the multipurpose wing and constructs a new support wing east of the auditorium.**

The roof on the auditorium would be replaced and a secondary structural support system would be introduced to bear the weight of the new roof structure.

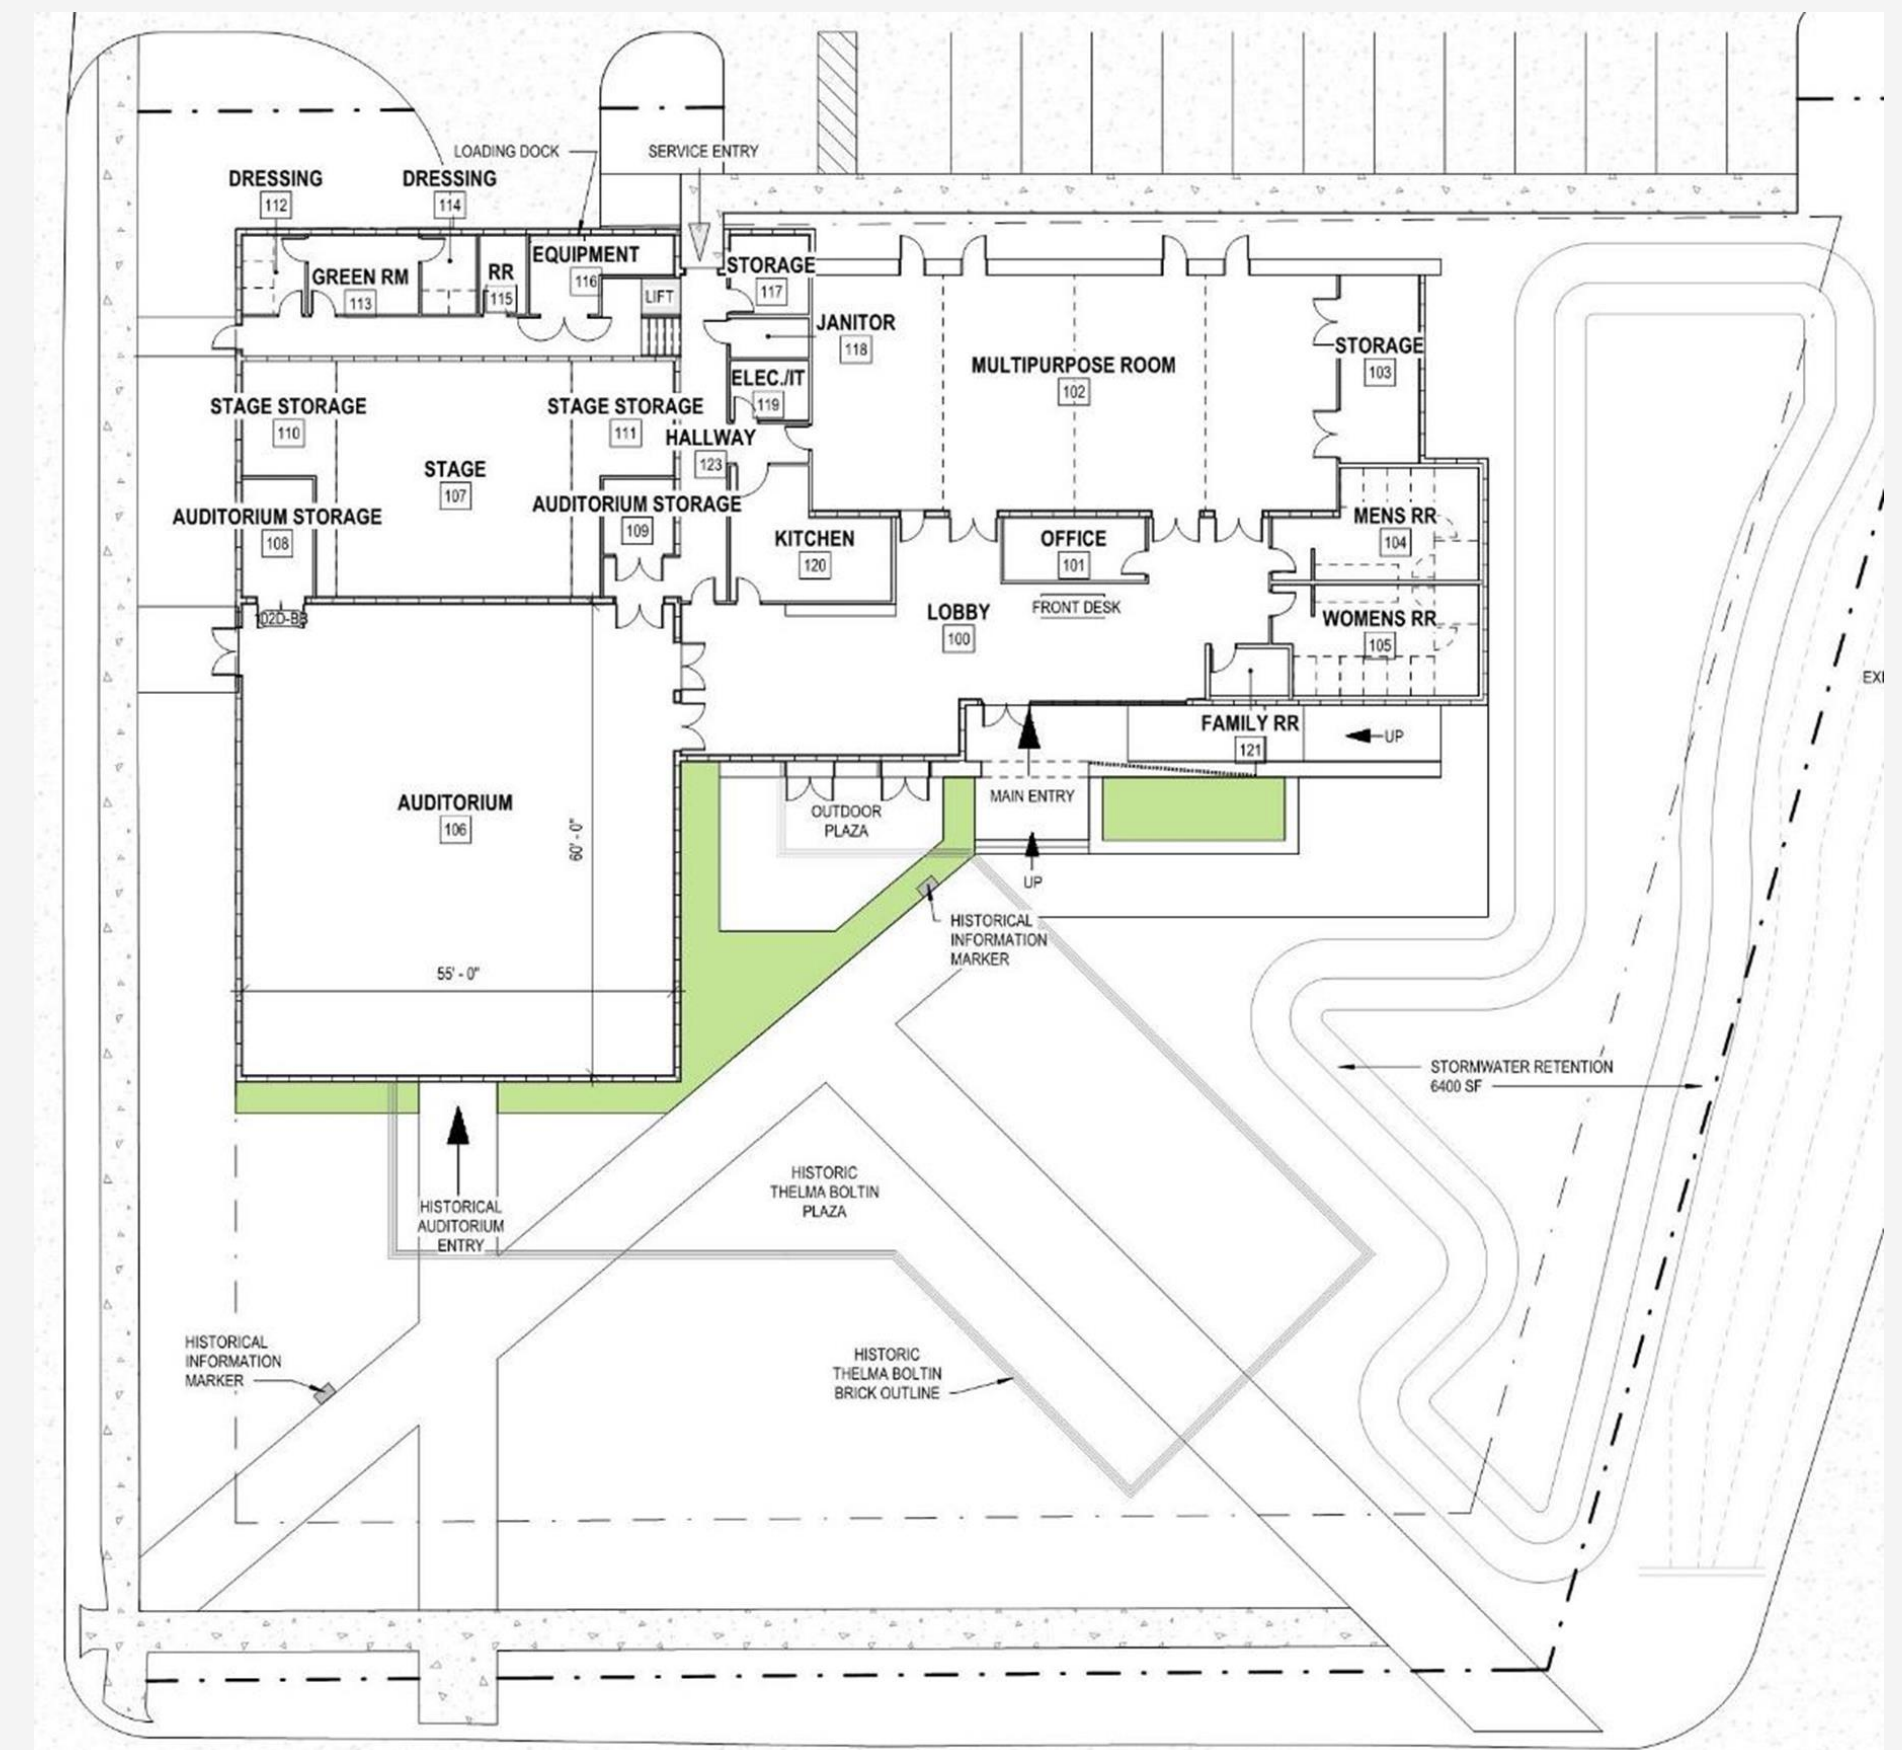
This option includes **complete demolition of all existing structures** and walkways and the construction of **entirely new facilities**.

The **auditorium is rebuilt** to match the existing architecture as closely as possible.

The **size increases** by 3,100 SF (34%) to provide **better programming space**.
