TABLE OF CONTENTS

HISTORY

STRUCTURAL REPORT

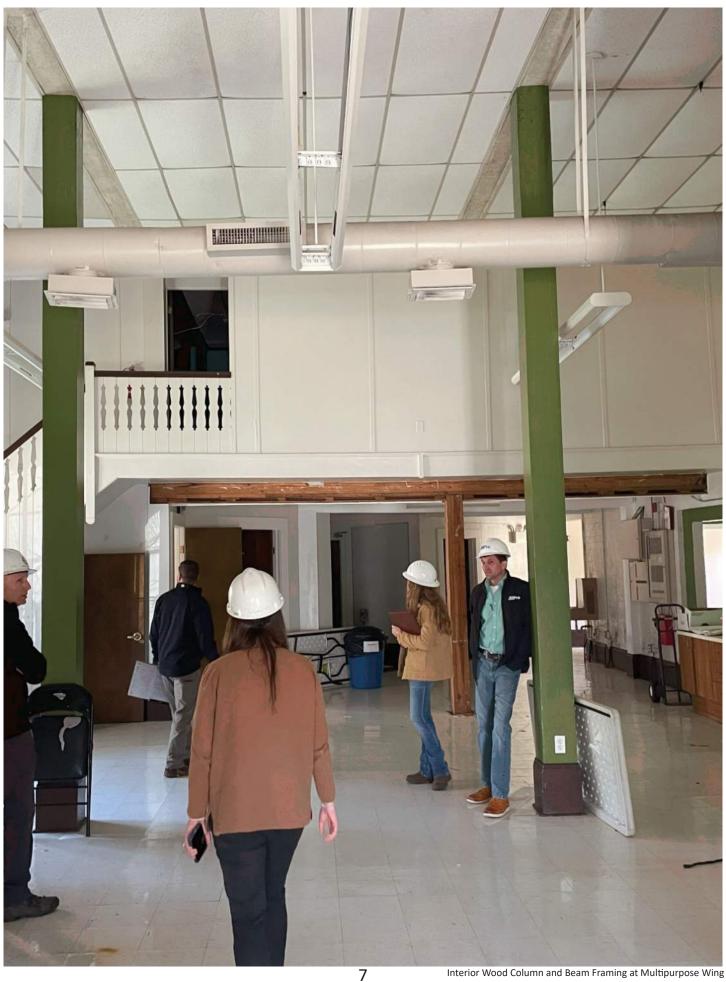
Typical Stage Floor Framing and CMU Piers

- The structural framing of the building is mostly hidden by interior finishes and not readily visible.
- The wood floor framing at the stage area is accessible via an exterior door on the Northeast side of the building. The visible portion of the wood joist/girder framing and CMU piers appear to be in satisfactory condition.
- Portions of the wing 2nd floor and roof wood framing are visible at some locations where ceilings/ soffits have been selectively removed. The wood columns, beams, joists and decking that is visible in the wing appears to be in good condition.
