## BOULWARE SPRINGS NATURE PARK PARK AND BUILDING REVITALIZATION

City of Gainesville: Wild Spaces Public Places | November 2022

BOULWARE SPRINGS NATURE PARK  
PARK AND BUILDING REVITALIZATION

**SUMMARY REPORT OF A  
GEOTECHNICAL SITE EXPLORATION**

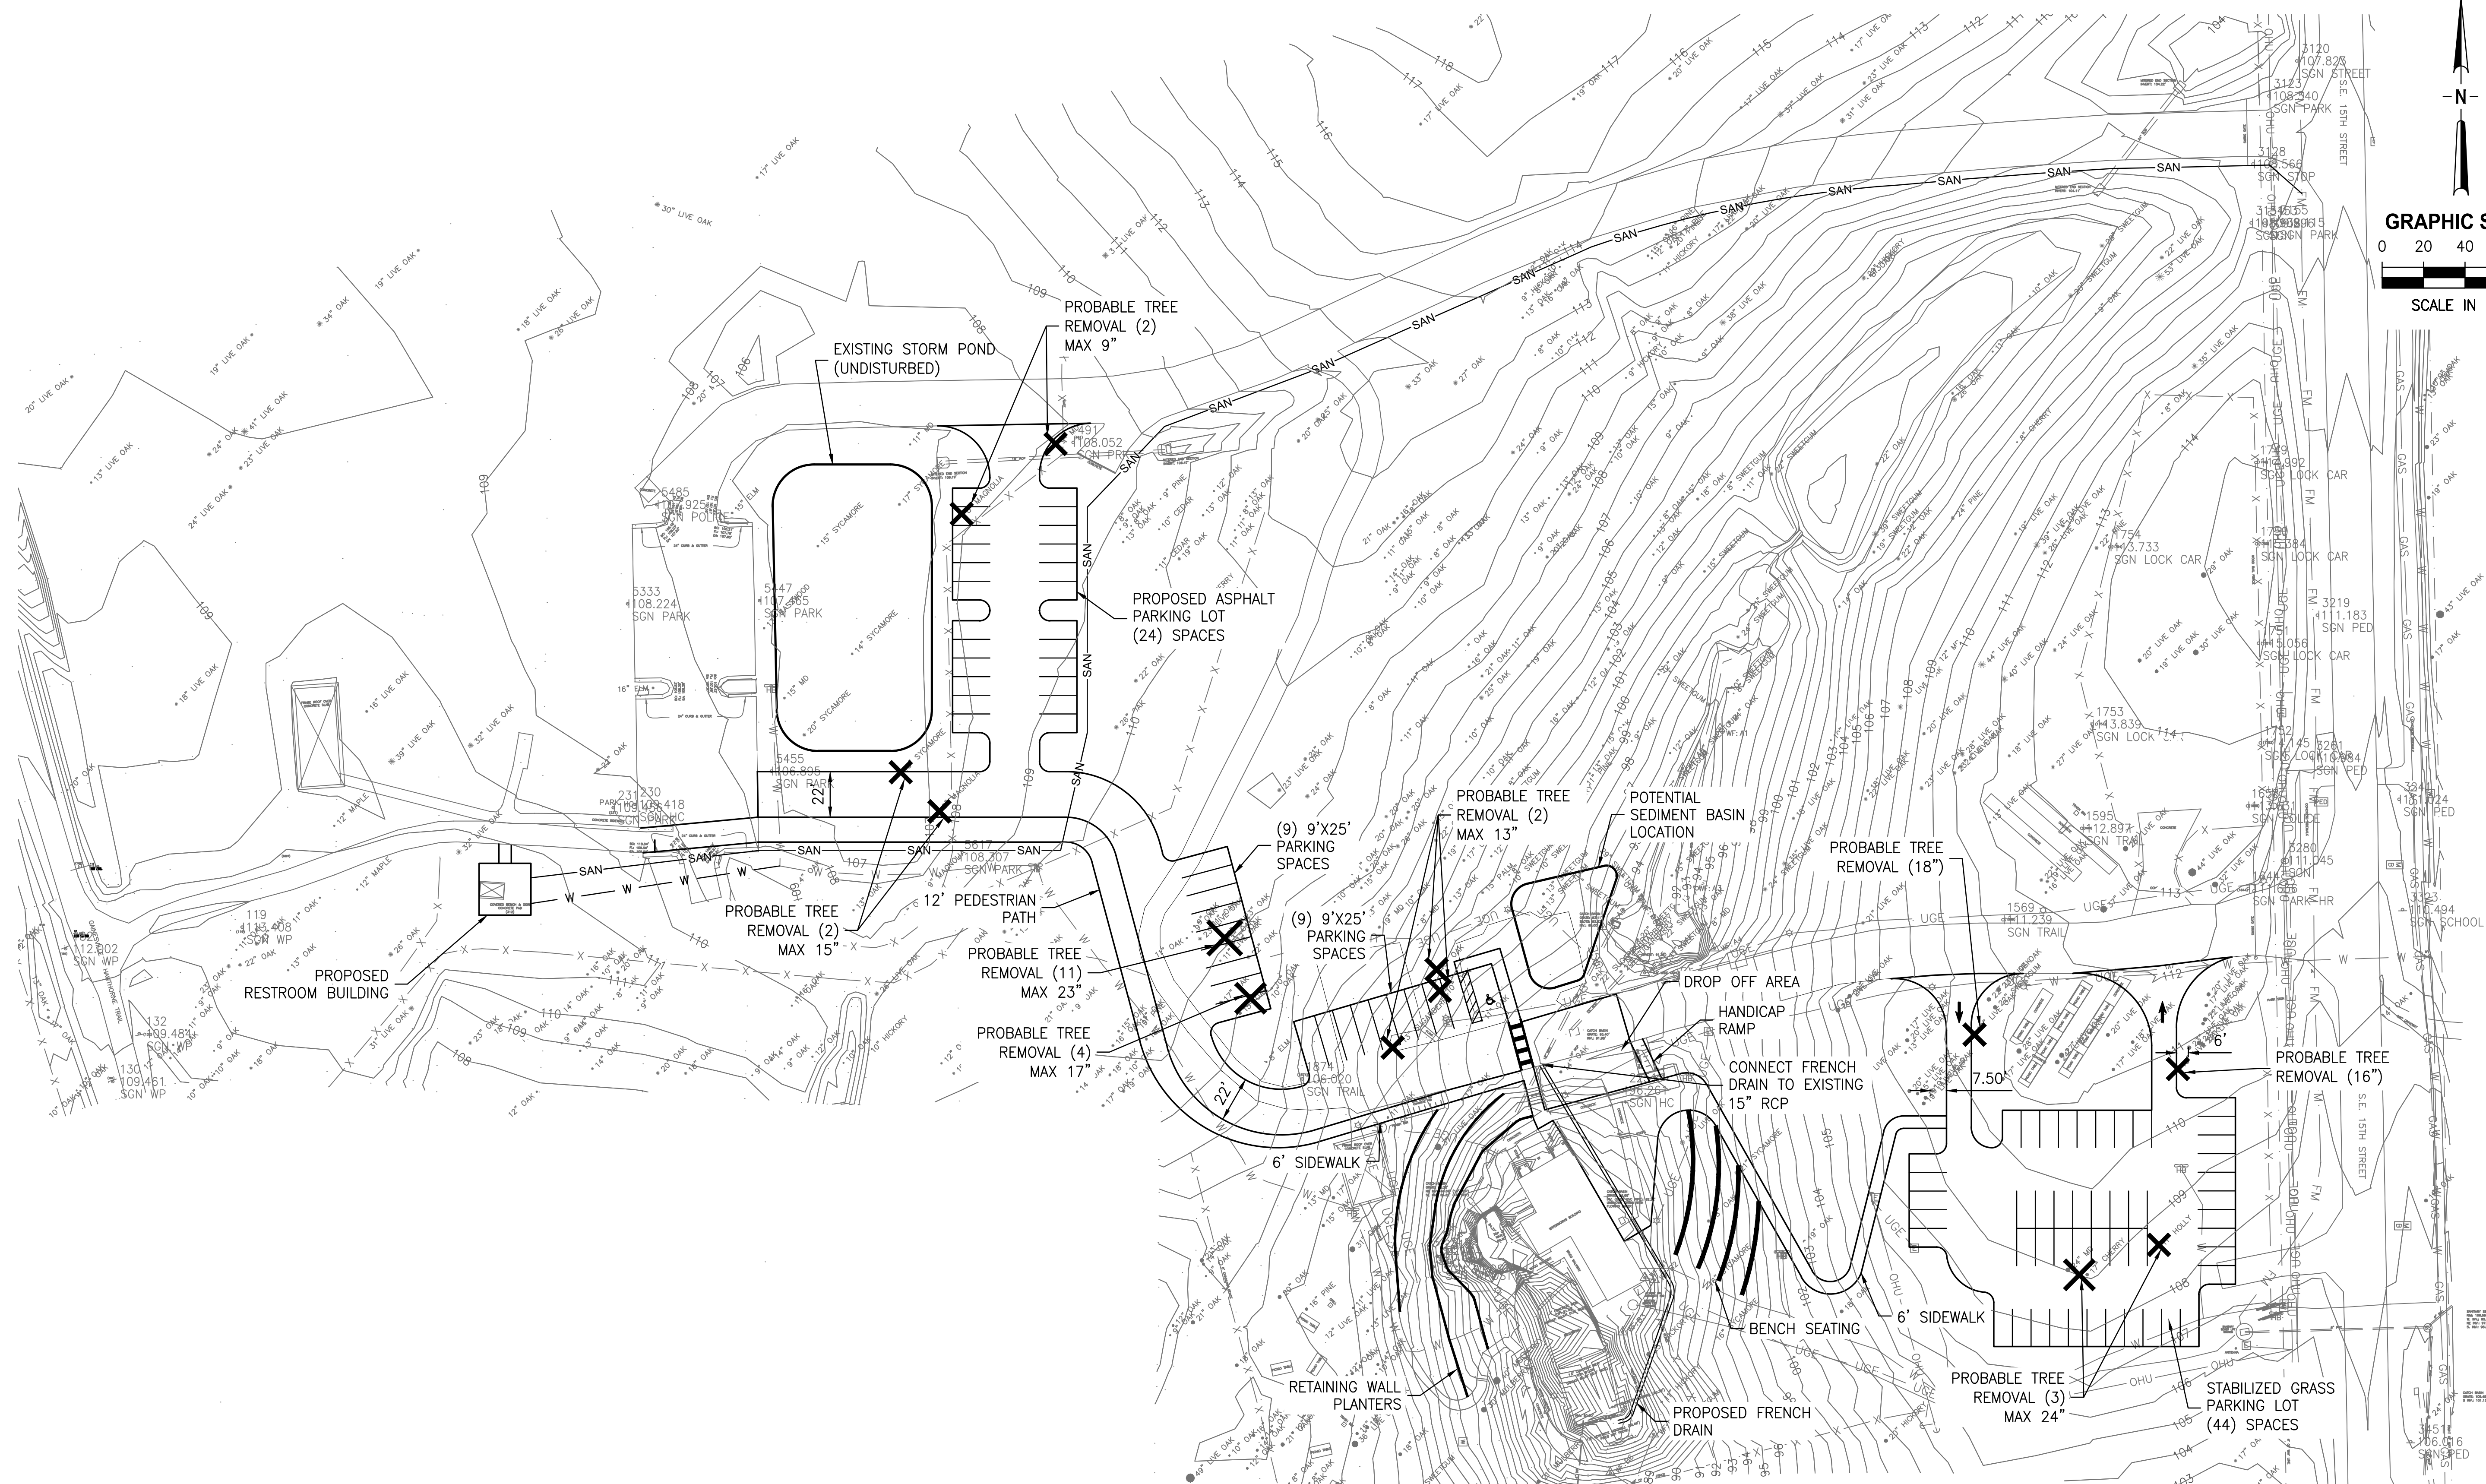
## Conceptual Future Site Layout

CITY OF GAINESVILLE  
WILD SPACES AND PUBLIC PLACES  
BOULWARE SPRINGS NATURE PARK IMPROVEMENTS  
SCHEMATIC DRAWING

Jones Edmunds and Manley Design, LLC performed site visits and reviewed existing data for Boulware Springs Nature Park. We considered facilities and features found in other City parks, current uses of Boulware Springs Nature Park and the goals and suggestions discussed with City staff at the kickoff meeting. We prepared a conceptual future site layout (Attachment 4) based on the findings and discussions. A conceptual master plan poster was then developed based on the site layout (Attachment 5).

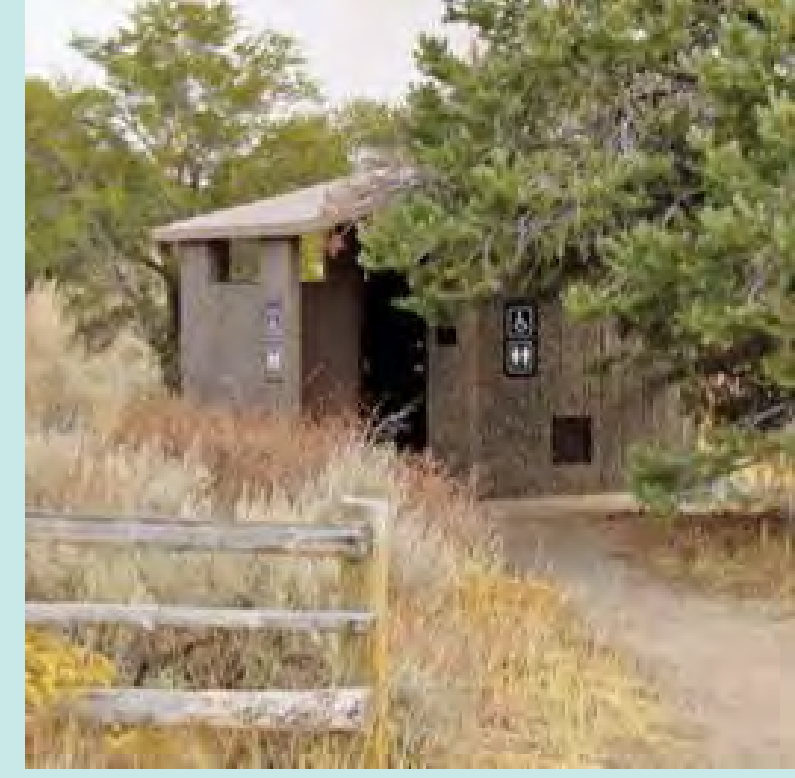
## A. TRAILHEAD

- Existing picnic pavilion to remain
- Existing educational kiosk moved to more central, visible location
- Bike racks moved to main access route
- New restroom
- New split-rail fencing along restoration areas to the north and west

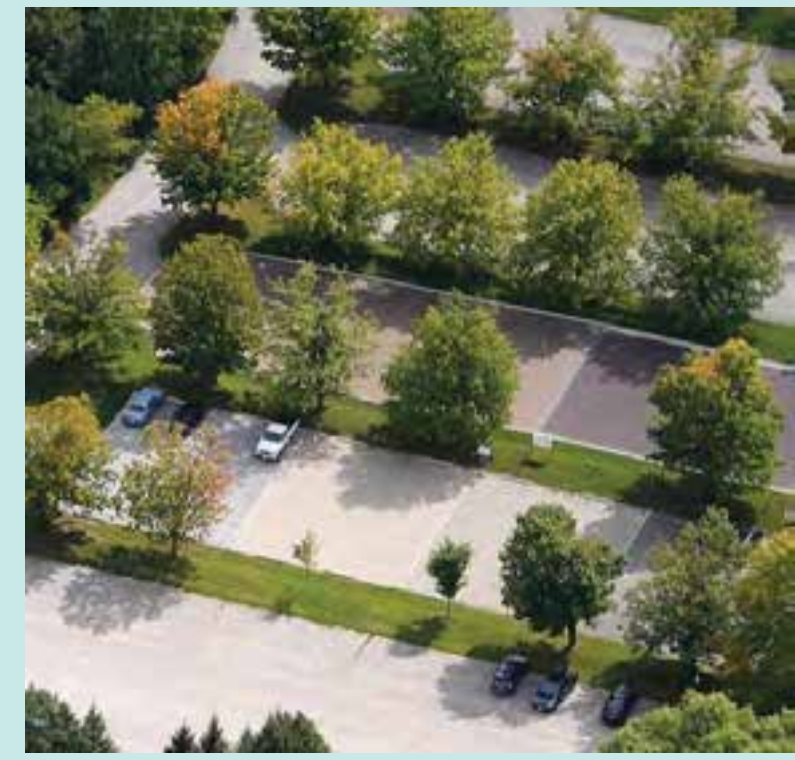
## B. TRAILHEAD PARKING

- Existing paved parking to remain
- Existing dry stormwater area to remain
- Existing equestrian parking re-purposed to new paved parking and overflow parking
- New parking along main loop road, shared between trailhead and Waterworks uses
- New trail along parking to trailhead and Waterworks area
- New plantings as required

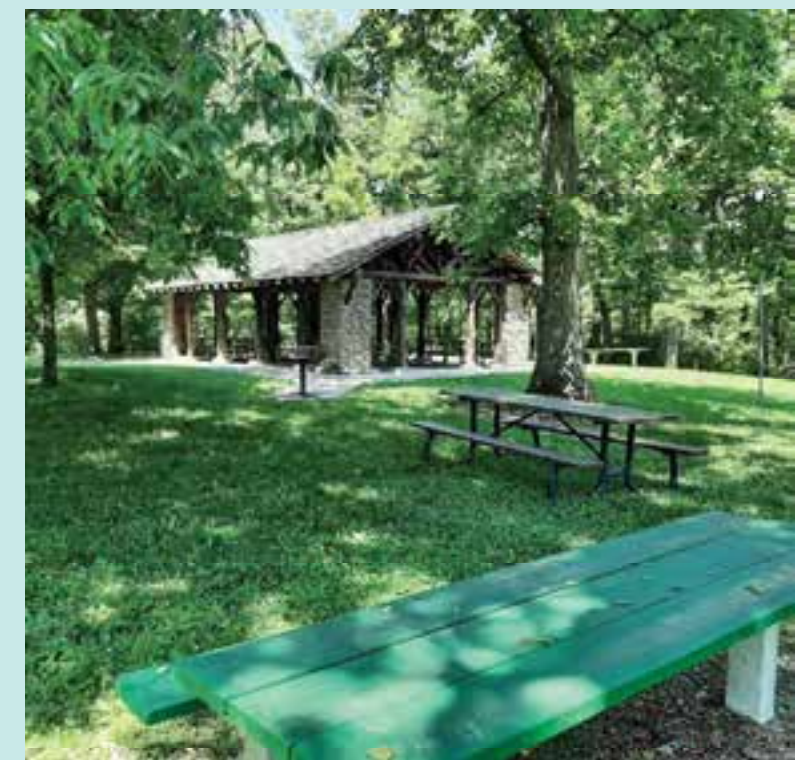
## C. PARK TRANSITION / PICNIC

- New loop trail through this picnic/passive use area to connect parking, use area and those improved areas along the back of Waterworks use areas
- New picnic pavilion and tables
- Educational signs
- Native plantings

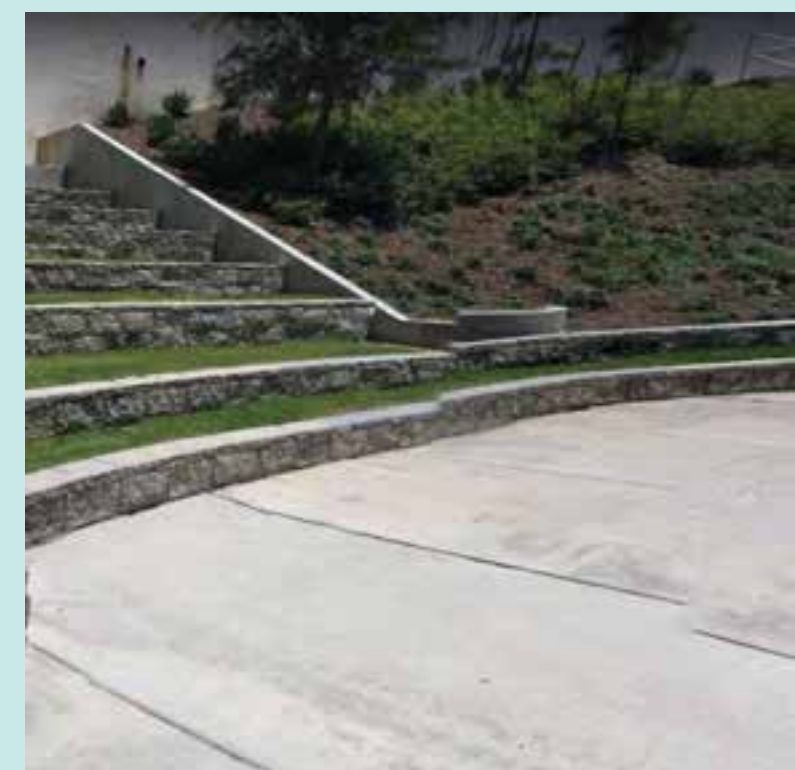
## D. WATERWORKS EXTERIOR USE AREAS

- New walk and handrail to replace existing along springs run edge
- New minor plaza space at spring head for gathering and educational use
- New retaining terrace walls to stabilize slope and prevent erosion. Bottom-most terrace wall along plaza edge to double as seating.
- Native plantings between other terrace walls
- Educational signage

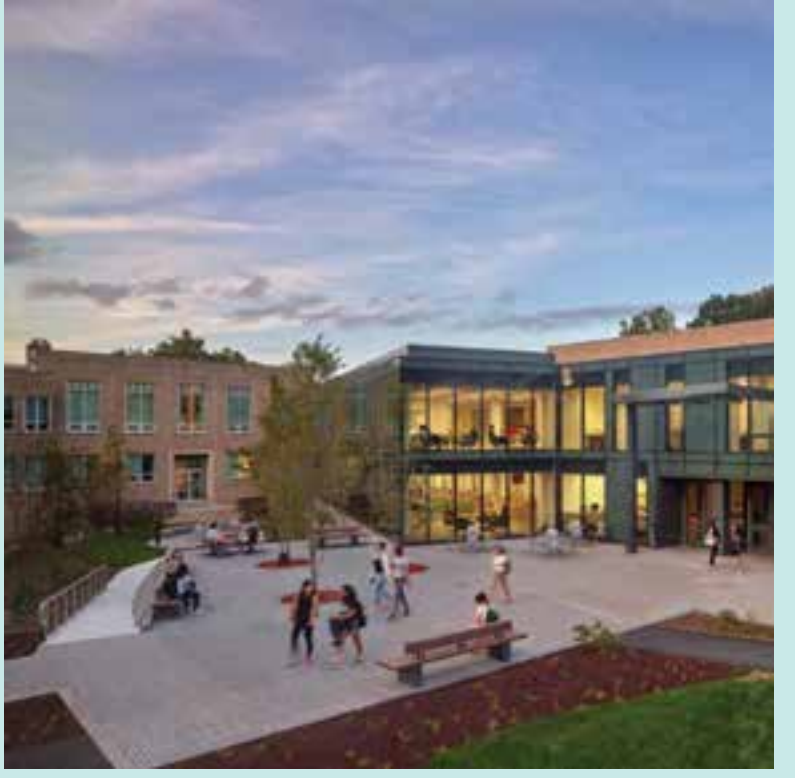
## E. WATERWORKS ENTRY

- New minor plaza at Waterworks Building entry to welcome and provide accessible, multi-purpose space for events
- Accessible walks to entry plaza and front entry of Waterworks building
- Educational signs

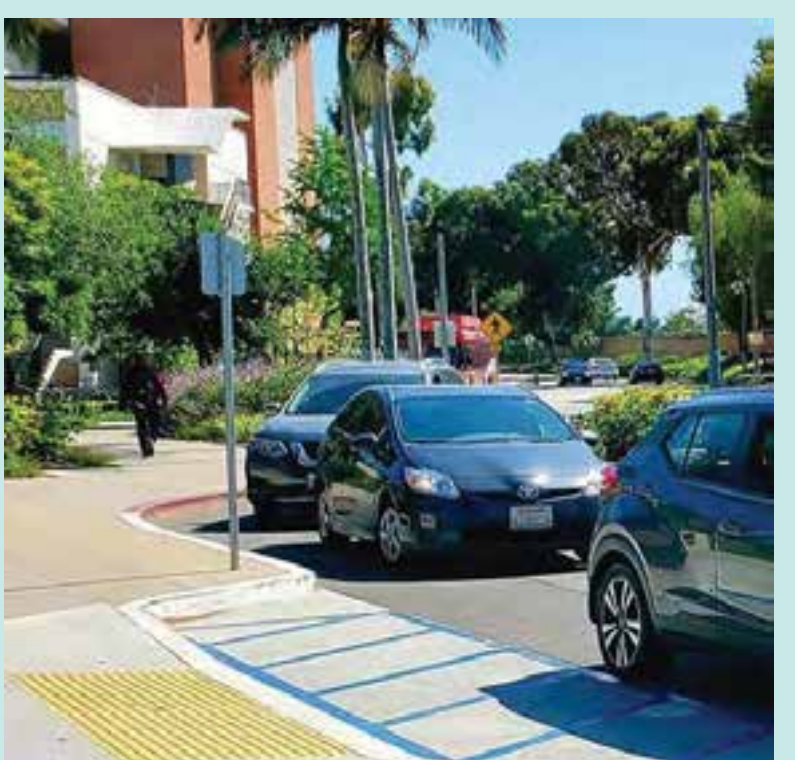
## F. WATERWORKS DROP-OFF & PARKING

- New drop off for easy access to Waterworks Building entry
- New paved parking
- New stormwater treatment for paved parking
- New trail and walk connections to Waterworks Building entry plaza and entry

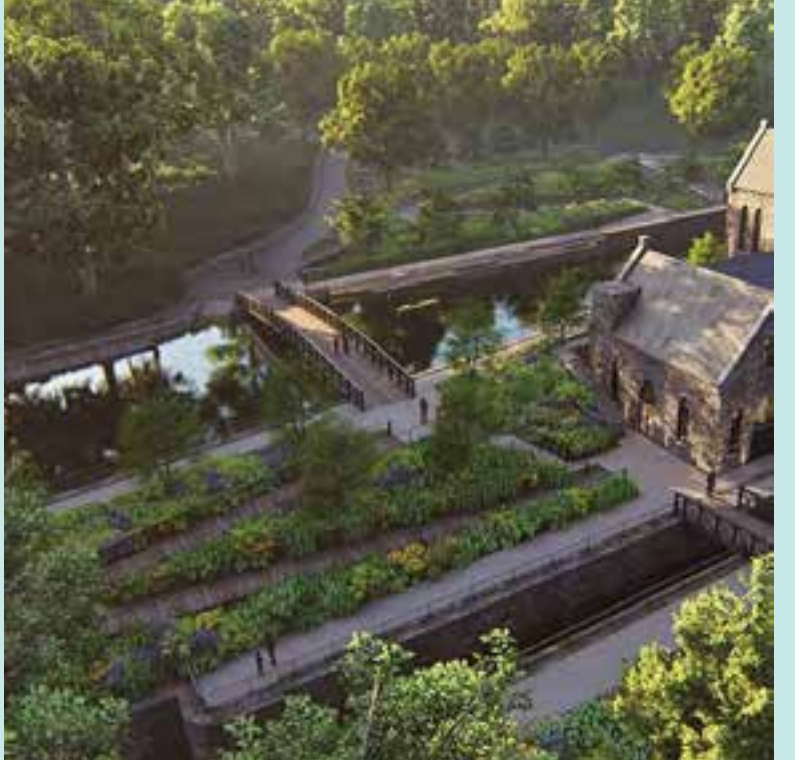
## G. WATERWORKS APPROACH

- New paved accessible walk from multi-use parking
- New retaining walls to support existing grade, prevent erosion, and avoid drainage issues into Waterworks Building

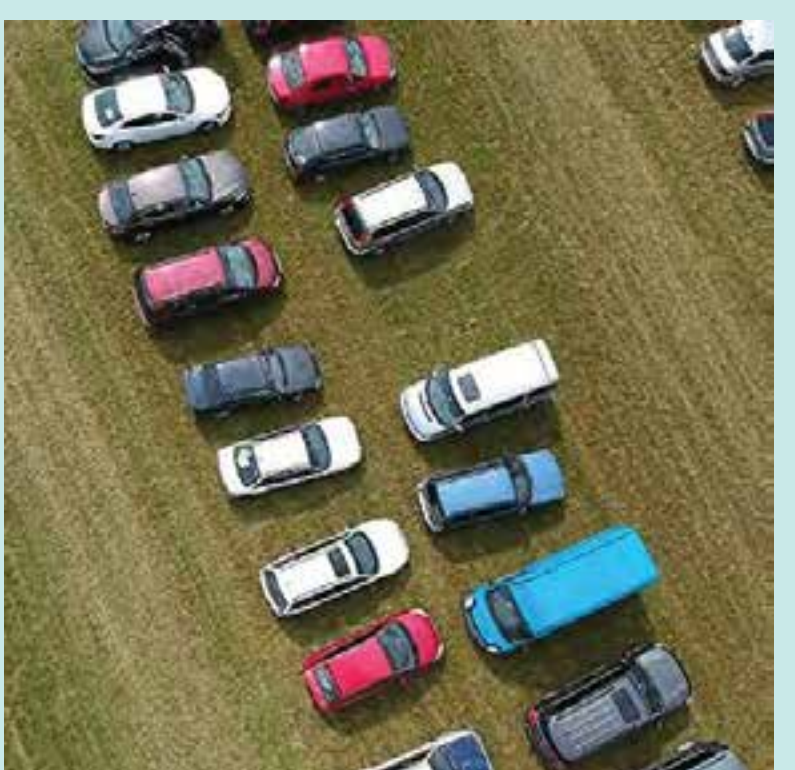
## H. MULTI-USE PARKING

- Existing unpaved parking to remain
- New stabilized grass parking for Waterworks Building, event, or Trailhead overflow parking in general location of previous care-givers homestead and positioned so as to not impact existing Live Oaks
- Native plantings to buffer and define parking

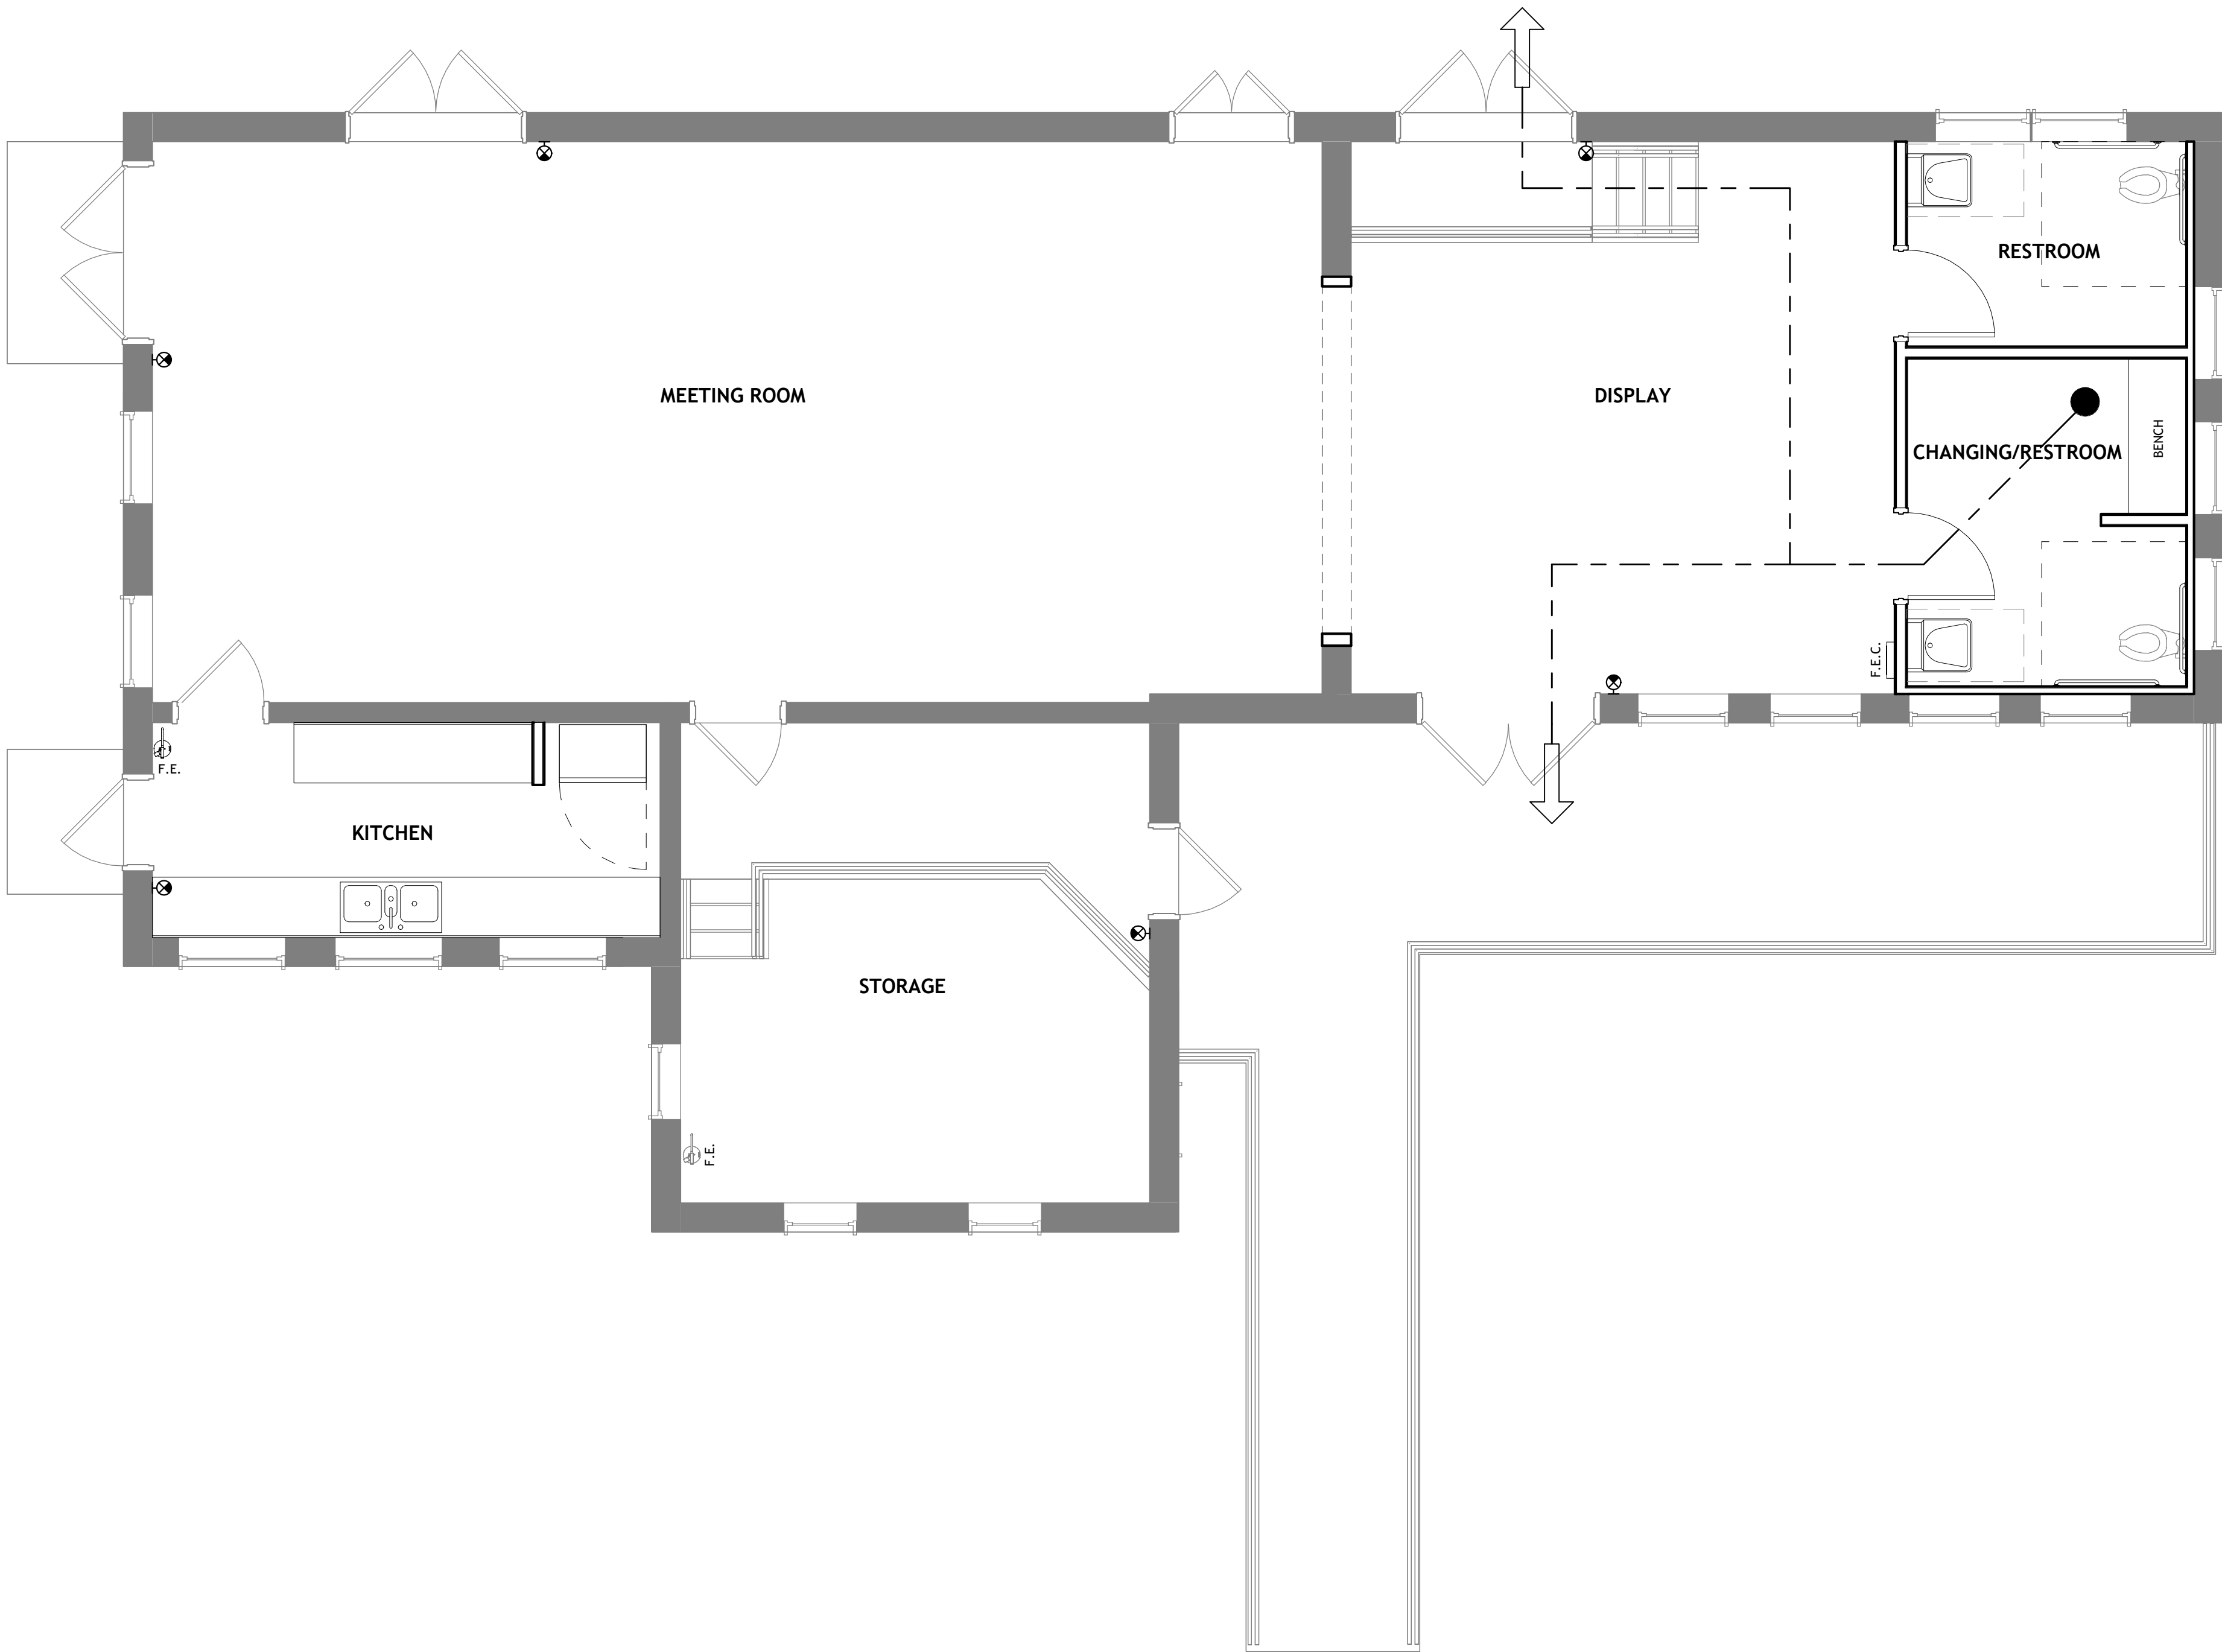
1 LIFE SAFETY FIRST FLOOR PLAN  
1/4" = 1'-0"

EXISTING BUILDING CODE SUMMARY	
OCCUPANCY CLASSIFICATION	OCCUPANCY = A - 2
EXISTING CONSTRUCTION TYPE	BUILDING TYPE = TYPE II B
FIRE SUPPRESSION SYSTEM	NON-SPRINKLERED
PORTABLE FIRE EXTINGUISHERS	PROVIDE 75 FT. MAX.
PROJECT SQUARE FOOTAGE	
MEETING ROOM & DISPLAY	(NET) 1,099 SQFT
KITCHEN	130 SQFT
STORAGE	269 SQFT
OCCUPANT LOAD	
MEETING ROOM	"A" ASSEMBLY 1,099 / 15 NET = 74
KITCHEN	165 / 200 GROSS = 1
STORAGE	315 / 300 GROSS = 2
FIRST FLOOR EGRESS REQUIREMENTS	
MINIMUM CORRIDOR WIDTH	77 OCC. X 0.2 INCH = 15.4 (44" MIN.)
MAXIMUM TRAVEL DISTANCE	200' (NON-SPRINKLERED)
COMMON PATH OF TRAVEL	75' (NON-SPRINKLERED)
MAXIMUM DEAD END CORRIDOR	20' (NON-SPRINKLERED)

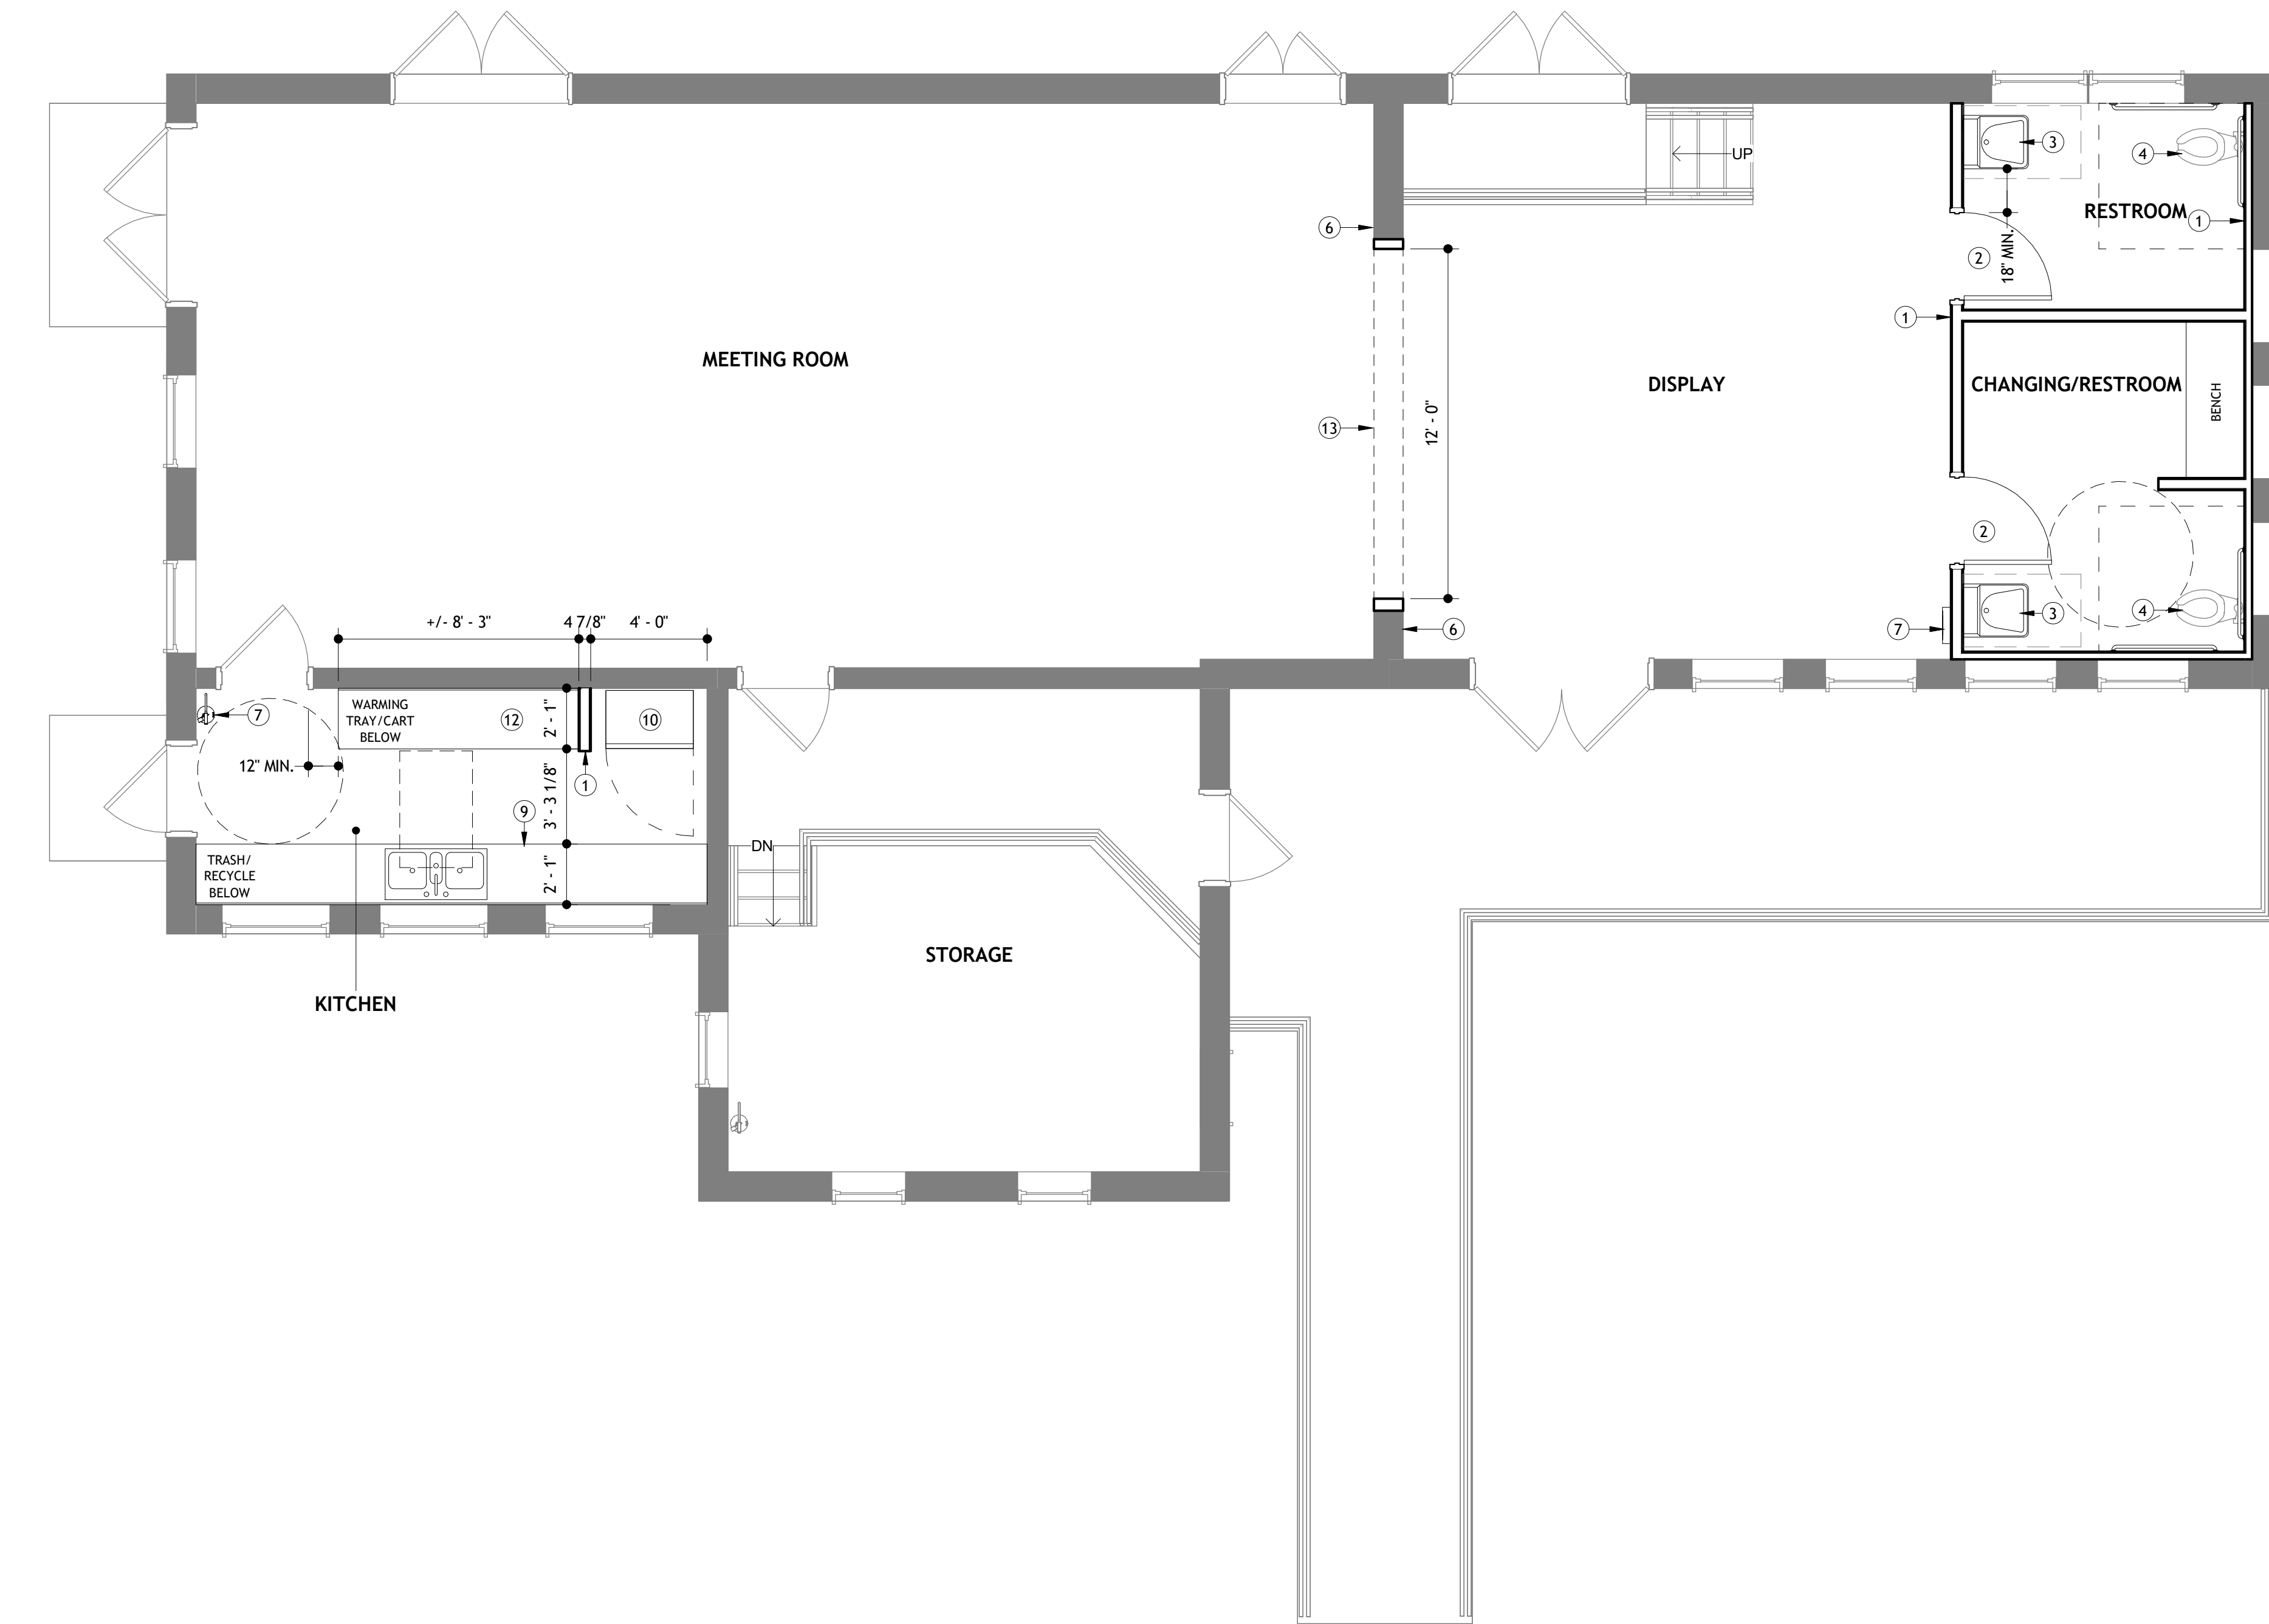
1 ARCHITECTURAL FIRST FLOOR RENOVATION PLAN - OPTION 1  
1/4" = 1'-0"

RENOVATION KEYNOTES	
1.	PAINT ON 5/8" GWB BOTH SIDES ON 3 5/8" METAL STUD WALL
2.	NEW 3070 DOOR, FRAME, AND HARDWARE
3.	NEW WALL MOUNT SINK (SEE PLUMBING)
4.	NEW FLOOR MOUNT TOILET (SEE PLUMBING)
5.	NEW GRAB BARS
6.	PAINT ON EXISTING WALL CORNER TO CORNER
7.	RELOCATED FIRE EXTINGUISHER OR F.E. CABINET (SEE FIRE PROTECTION)
8.	RELOCATED ELETRIC WATER COOLER (SEE ELECTRICAL)
9.	NEW COUNTER TOP, CASEWORK, STAINLESS UNDERMOUNT SINK AND FAUCET
10.	NEW REFRIGERATOR (O.F.C.I.)
11.	PAINT ON 5/8" GWB ON 1 1/2" METAL STUD WALL
12.	NEW COUNTER TOP AT 42" AFF. WITH SUPPORT BRACKET
13.	FINISHED ARCH OPENING
